# Peabody Coal – Channel Field Trial for Rock Replacement

ShearForce10 ECTRM Installed over cool season grass mix in high flow channel at the base of an overburden cap on September 10, 2019. Objective: Evaluate potential as rock riprap replacement in high flow areas.

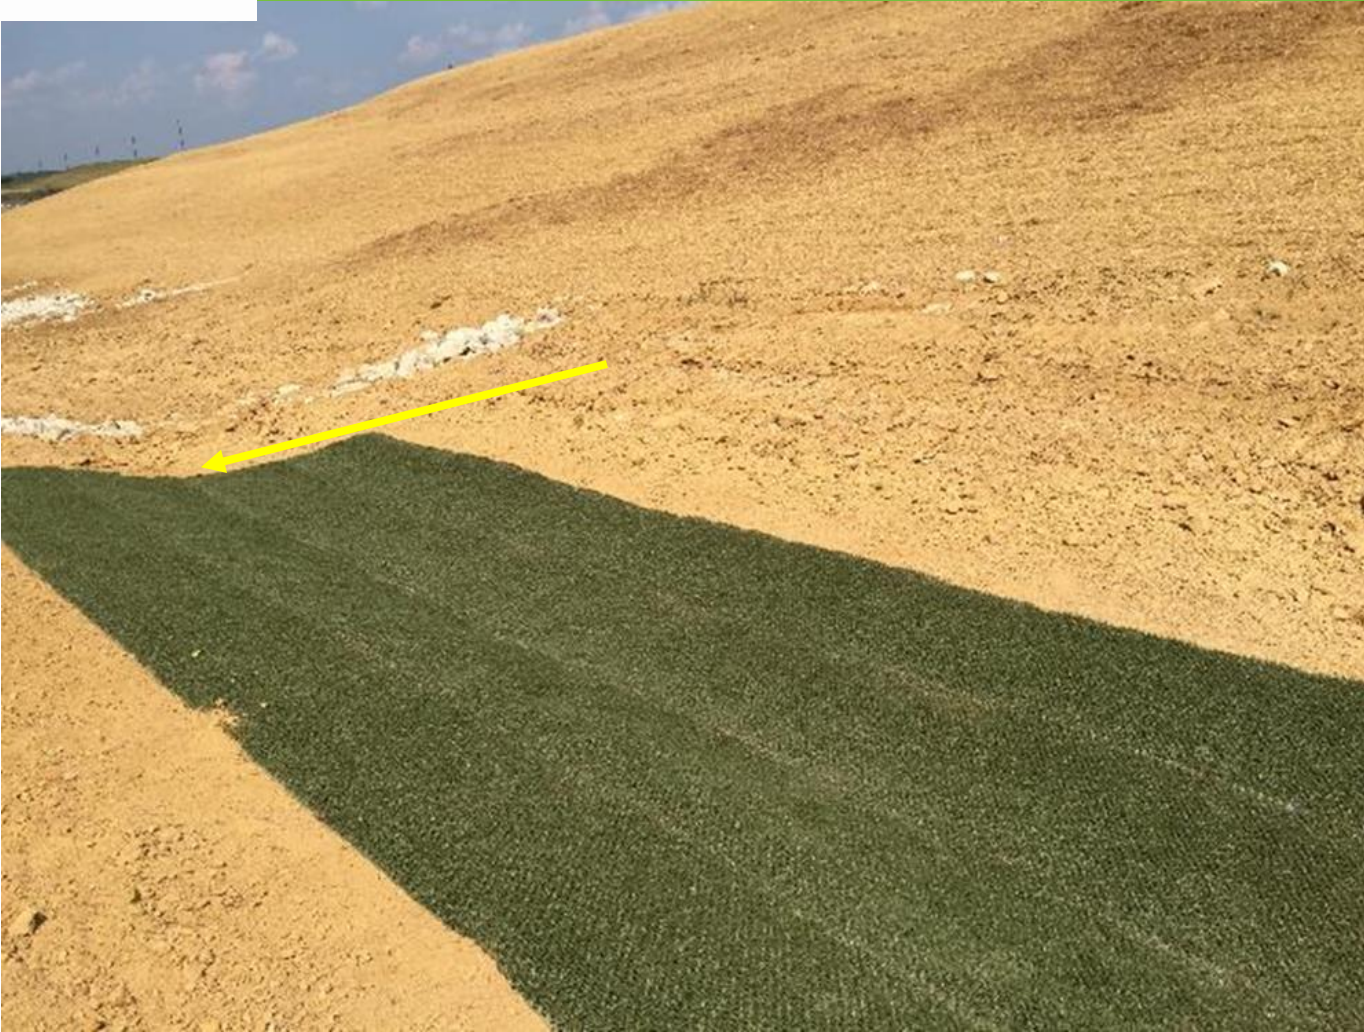
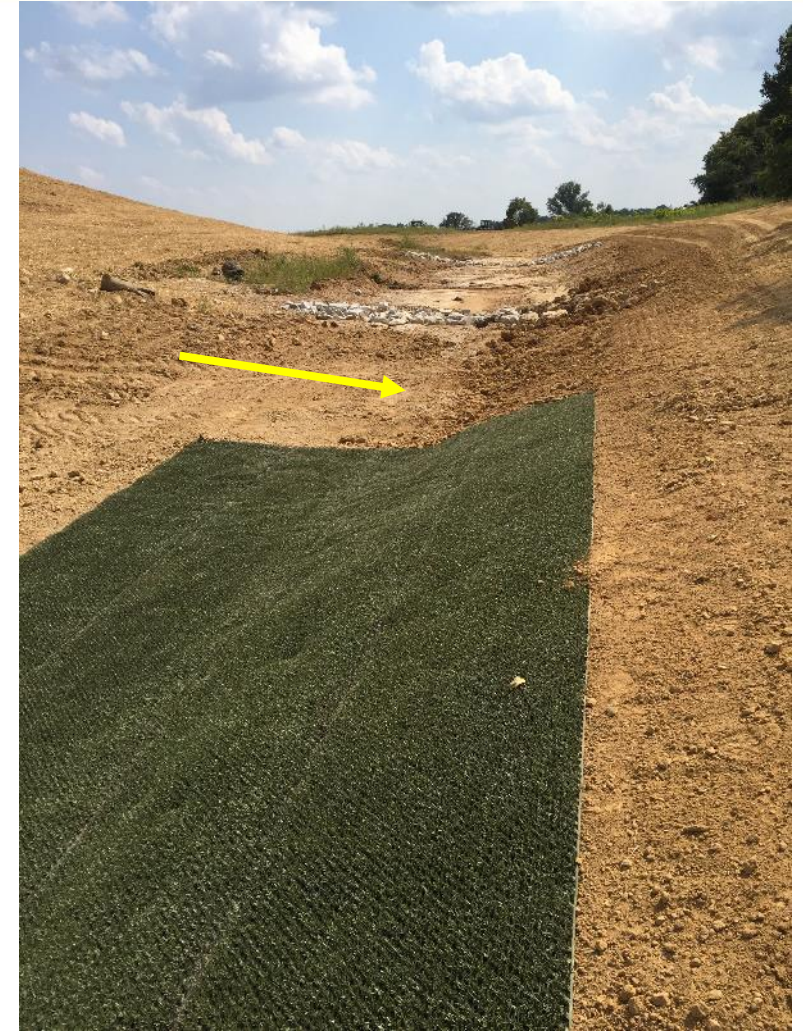
Mats were installed between rock checks using 8 inch sod staples and 6 inch fabric pins on 1.5 ft centers according to published InstaTurf installation guidelines. Note small sections of channel downstream and upstream of mats left unprotected for comparison.

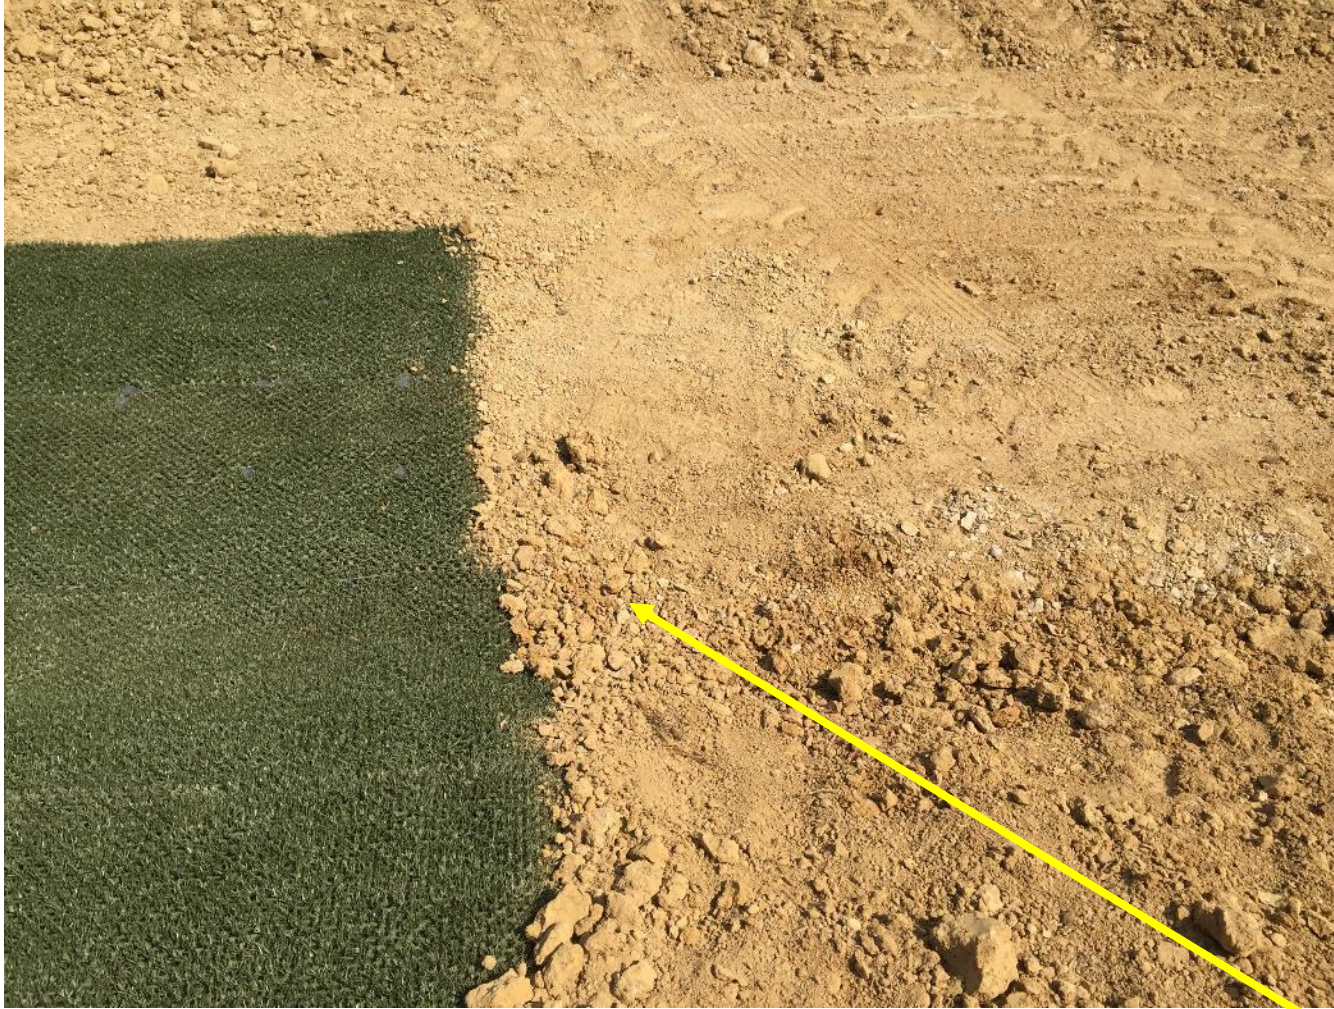
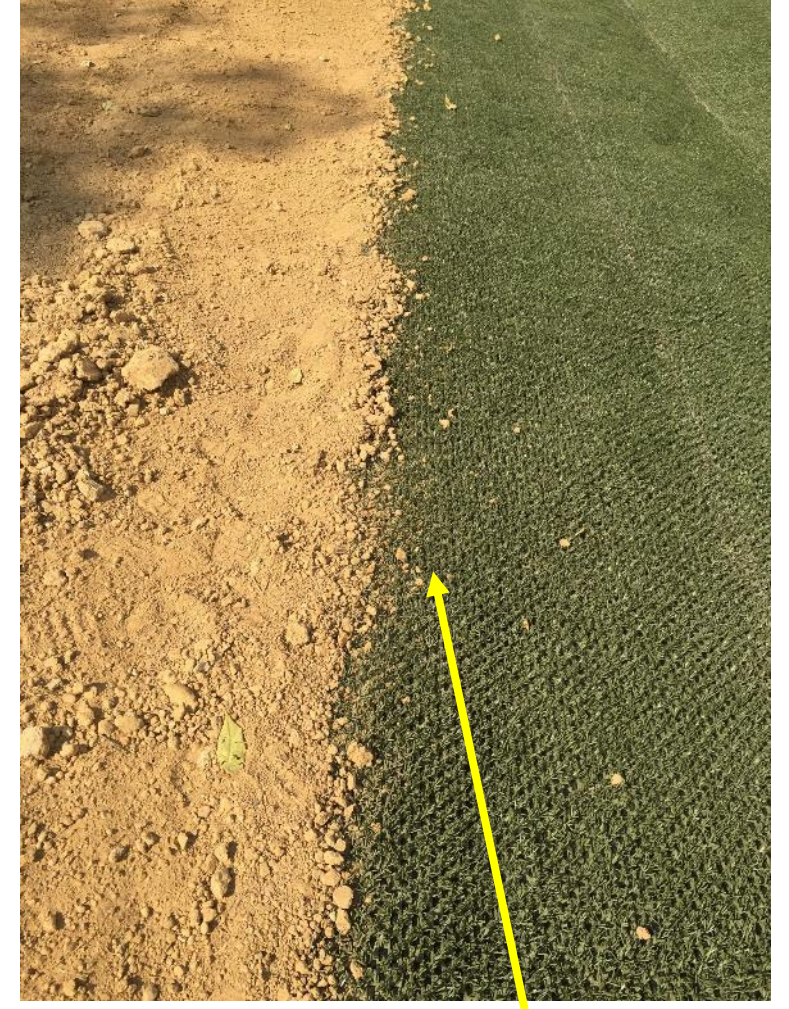
Upslope terminal ends of mats were trenched in approximately 6 inches (left). Mat edges at top of both sideslopes (Right photo) and downstream terminal ends were simply stapled on 9 inch centers with loose soil placed over edges.

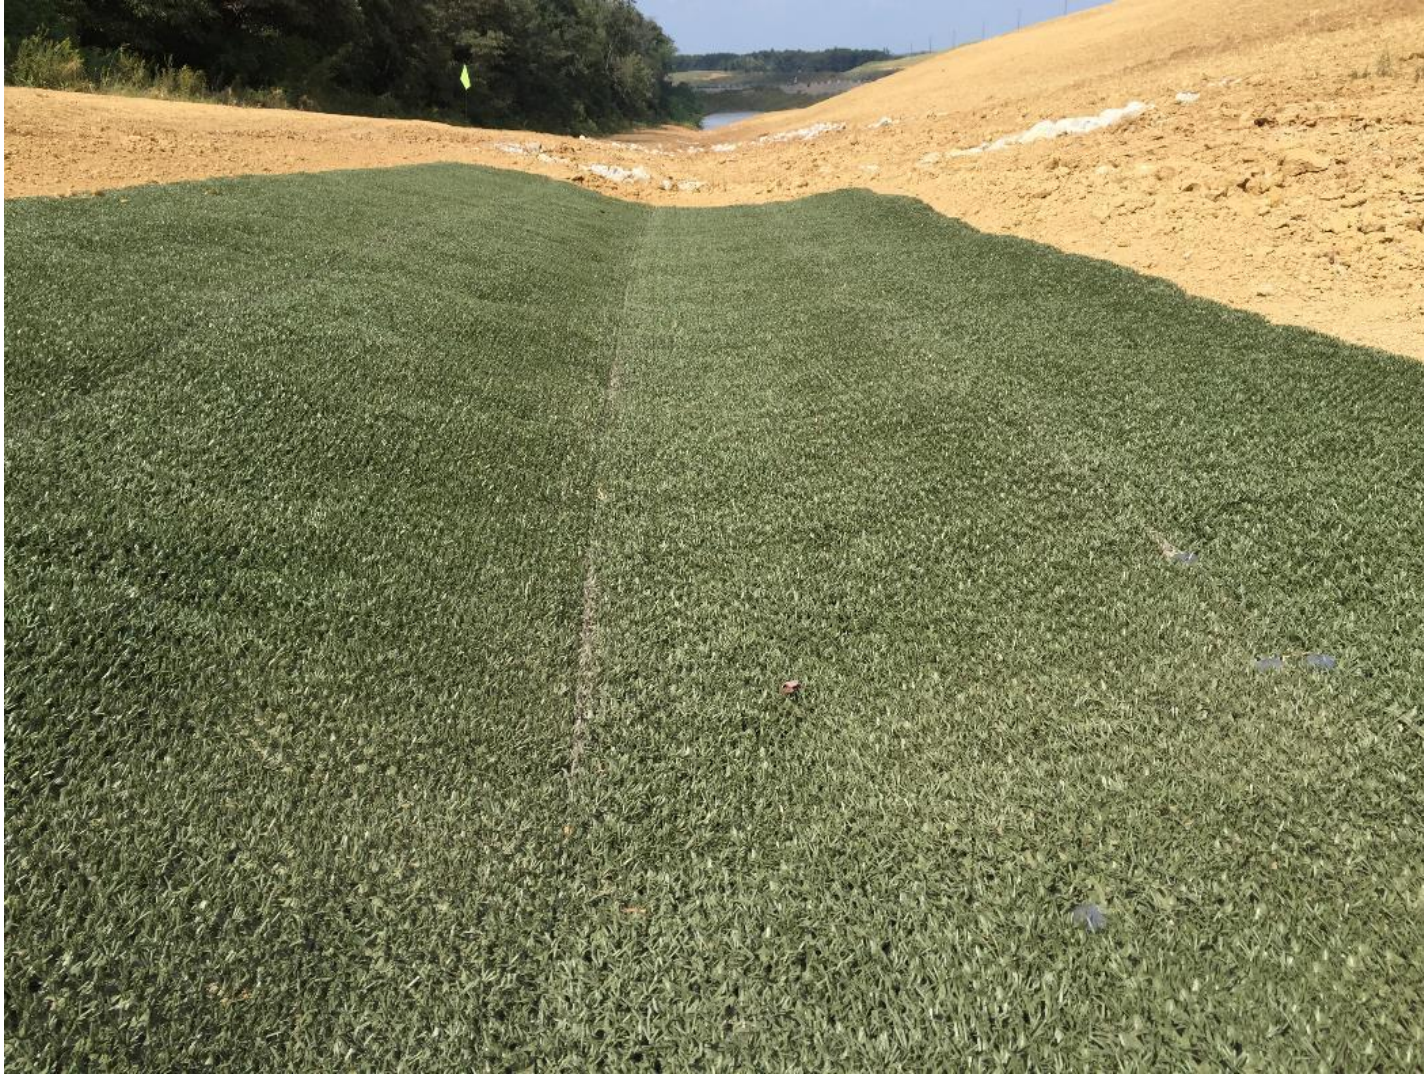
Completed ShearForce10 Installation looking down channel grade

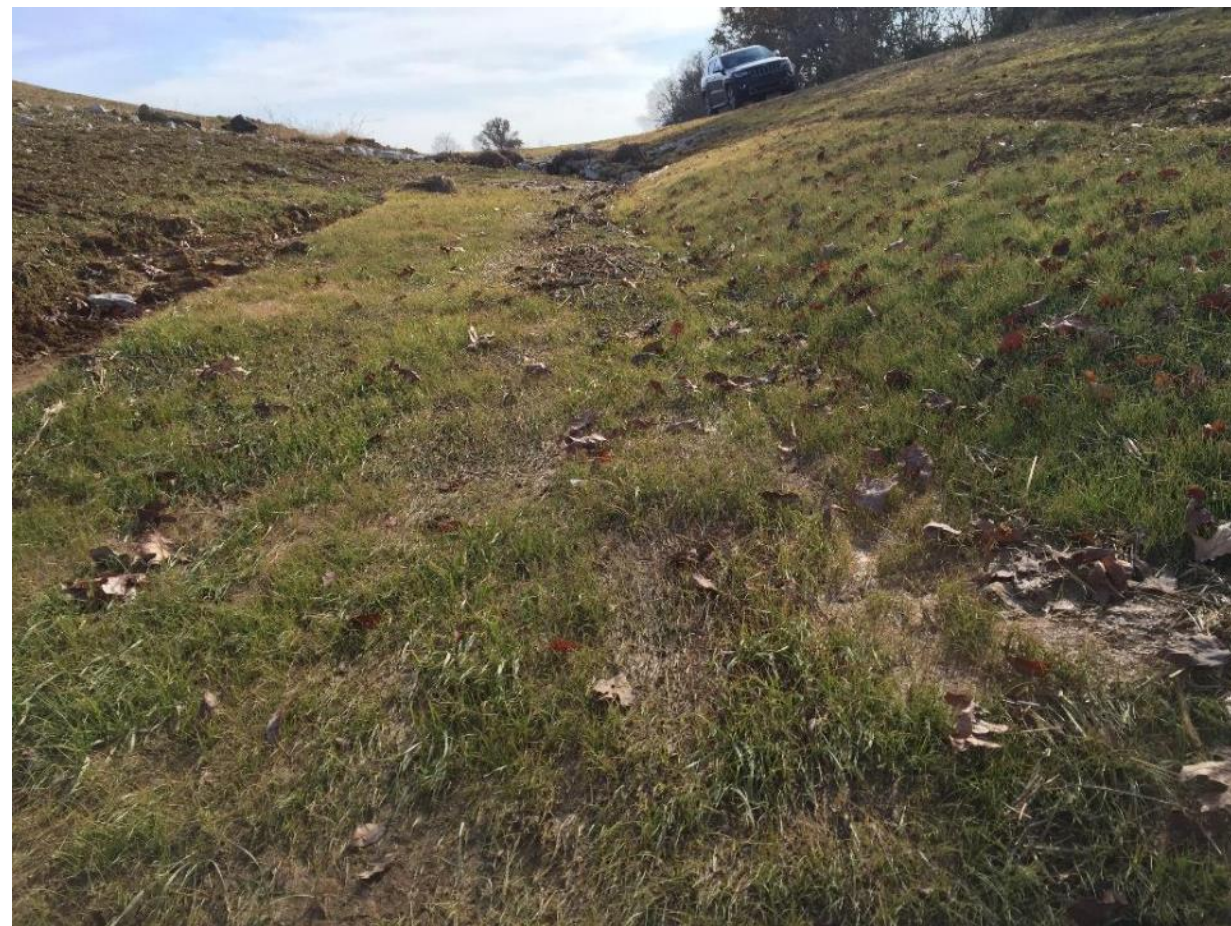
Upslope view of ShearForce10 just after installation on Sep 10 (left) and on Nov 20 (right).

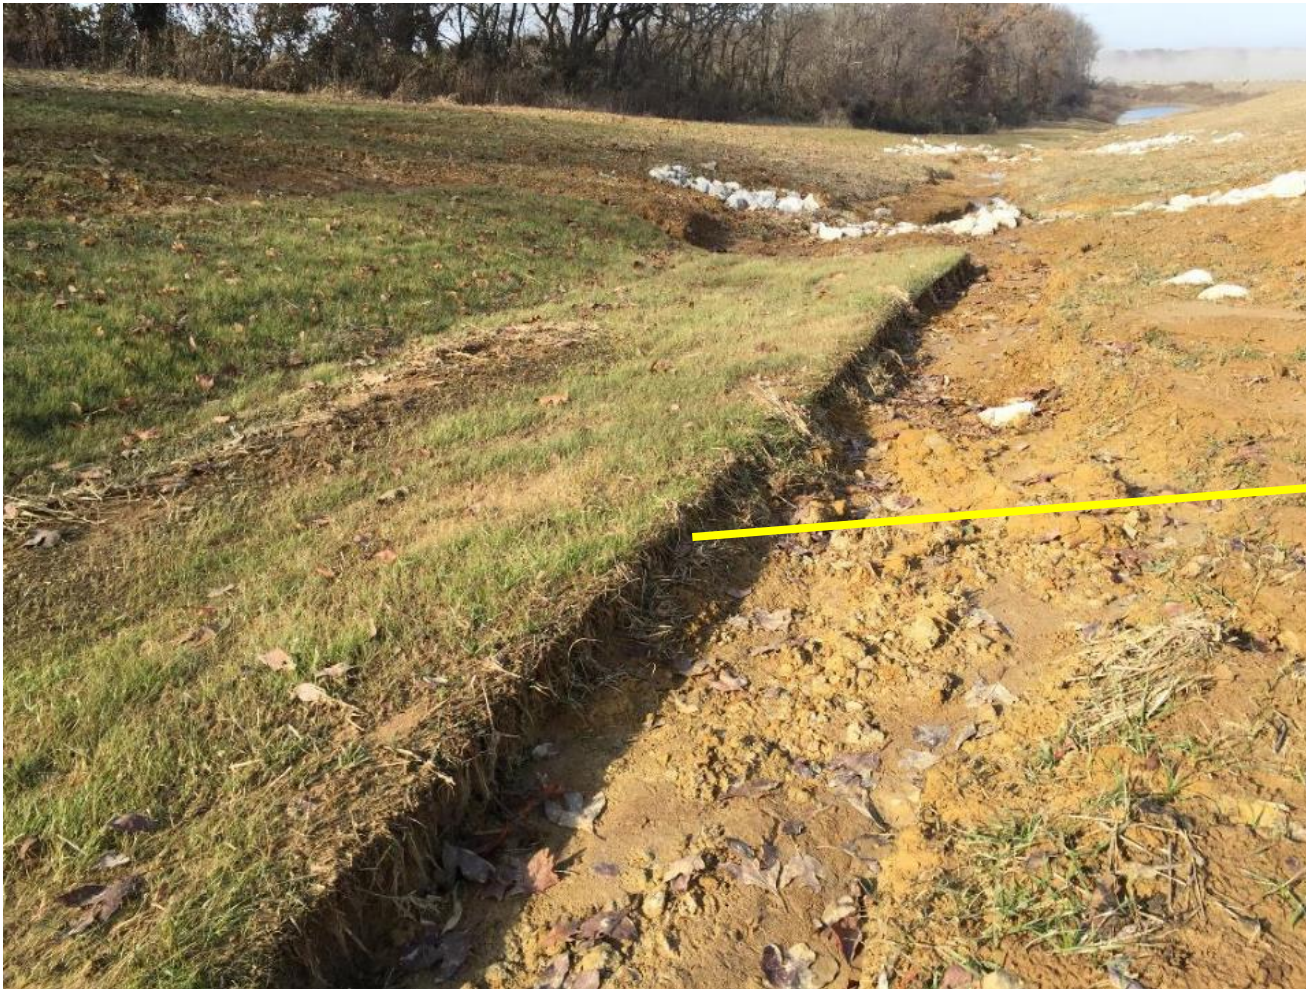
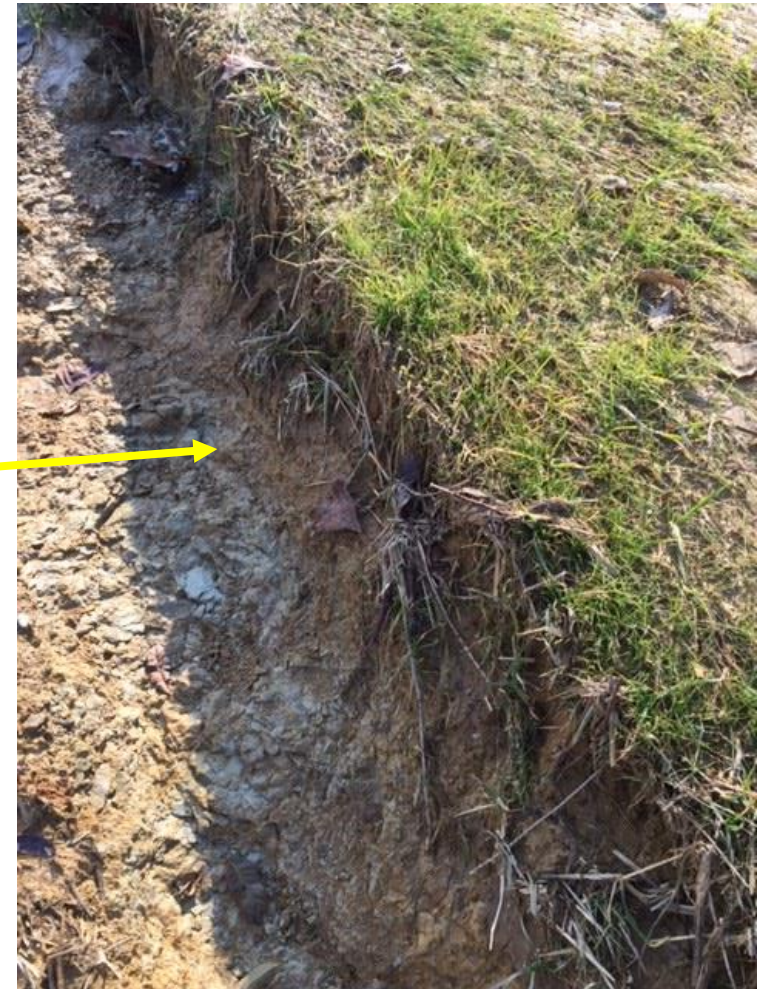
But wait, there's more. Apparently we should've used more ShearForce10! The right sideslope (looking downstream) where no ShearForce10 was used was badly scoured by over 8 inches. Incredibly, the ShearForce10 prevented erosion of soils and vegetation directly under it. Never seen anything like this before!

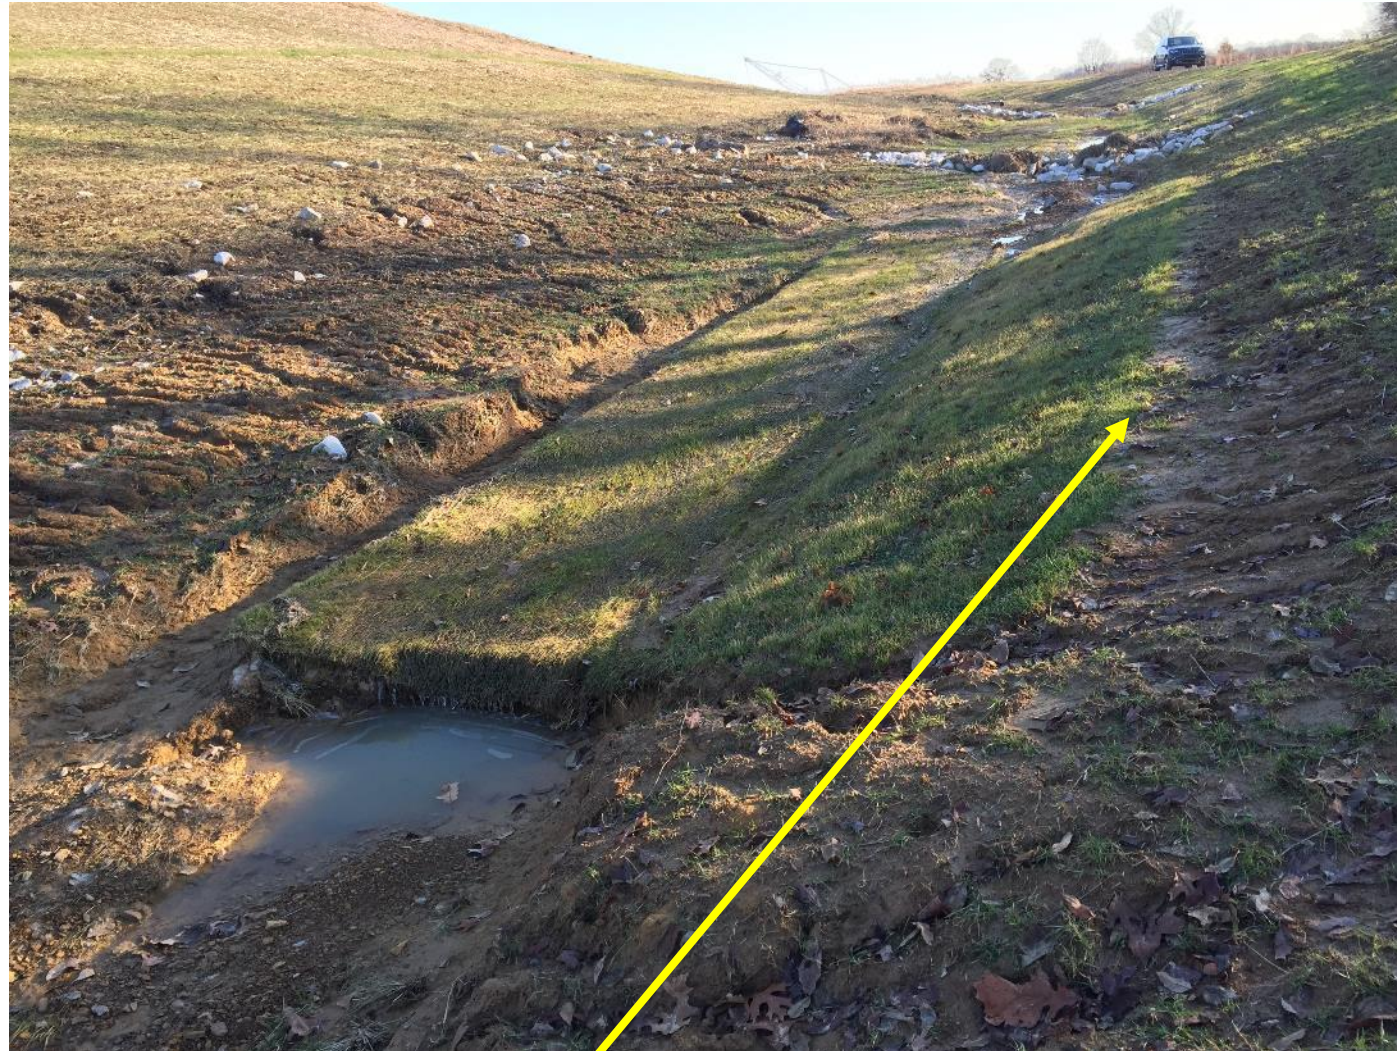
The staple anchor check at top edge of left sideslope (if looking downstream) effectively prevented rills in unprotected upslope area from undermining the ShearForce10.

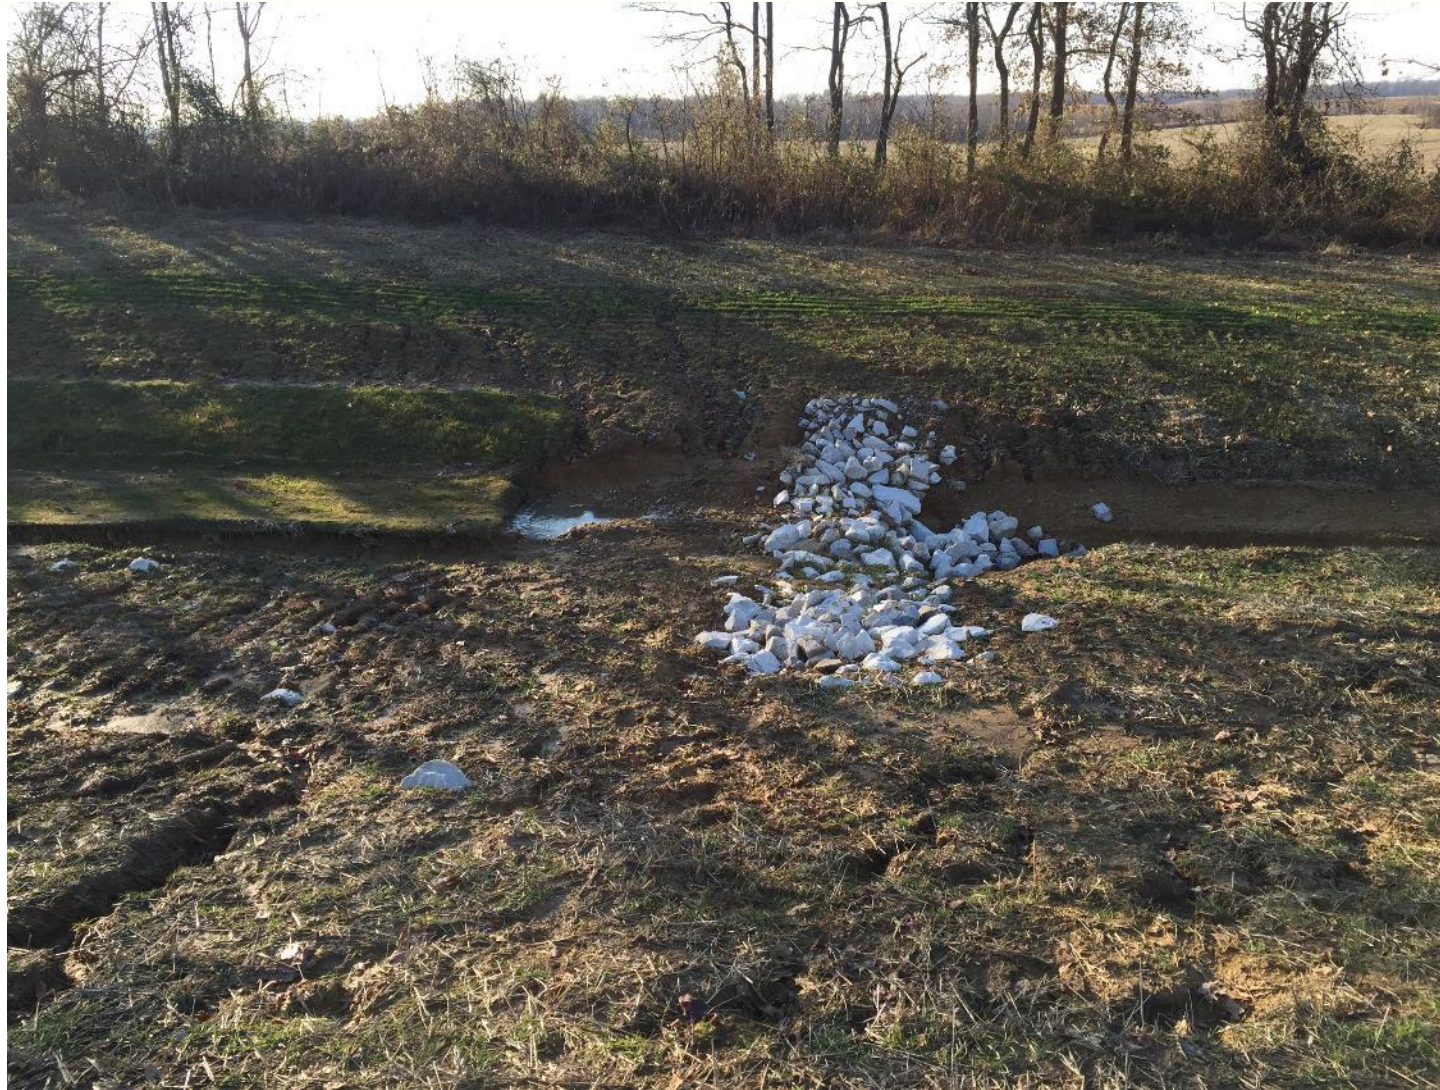
The unprotected area downstream from the ShearForce10 and rock check exhibited severe scour.

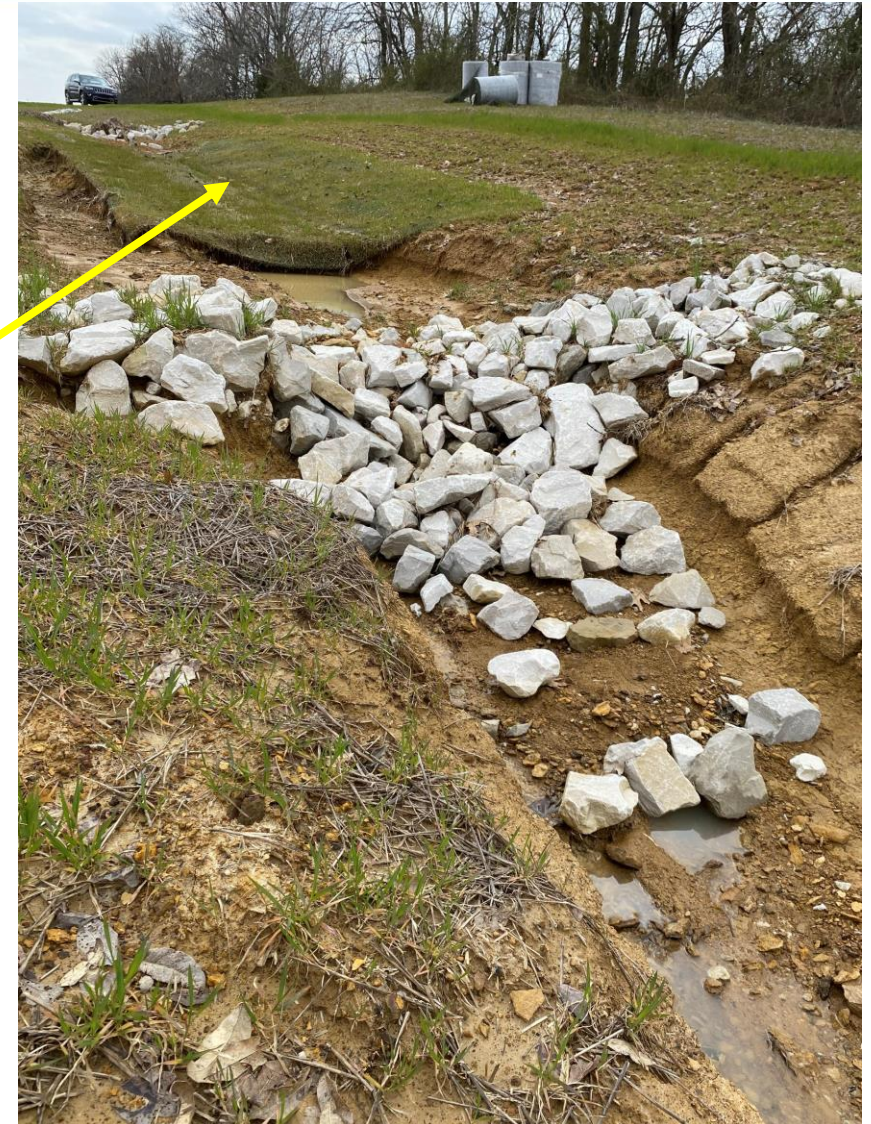
In mid-March 2020, the ShearForce10 test section was still solid, in spite of an extremely rainy winter with no snow fall. However, the rock check dams above and below the ShearForce10 test section had blown out.
