Peabody Coal High Flow Channel Lining
Project
ShearForce10 Hybrid-Turf Instant Armor Mat

Peabody Coal Channel Project Details

Peabody Coal – ShearForce10 Instant Armor Mat Field Trial

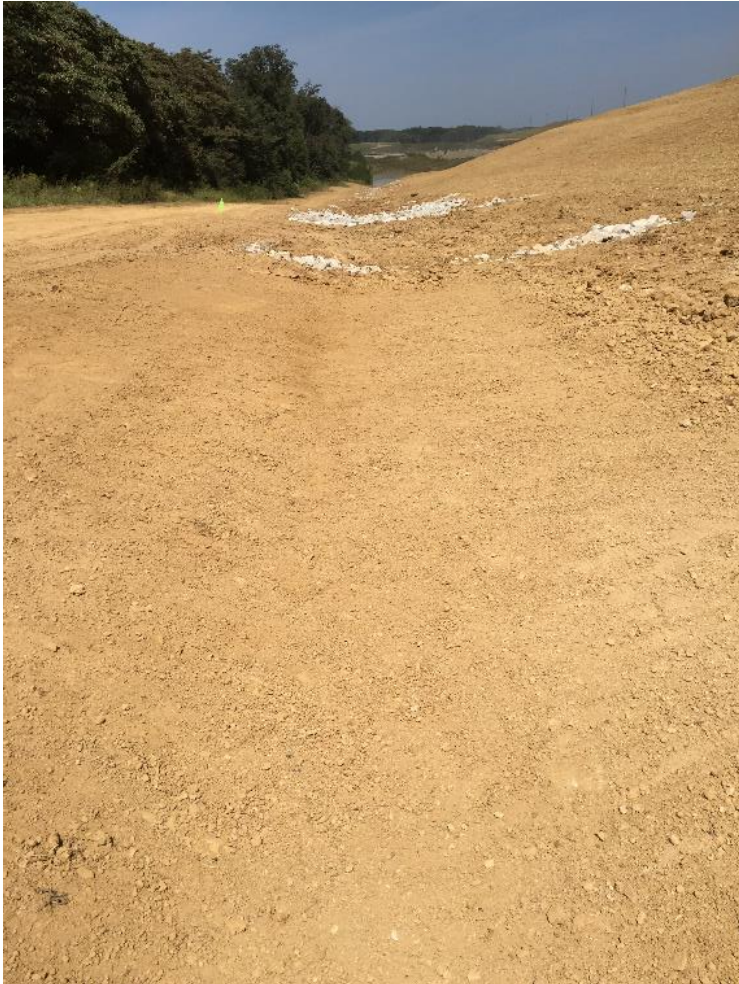
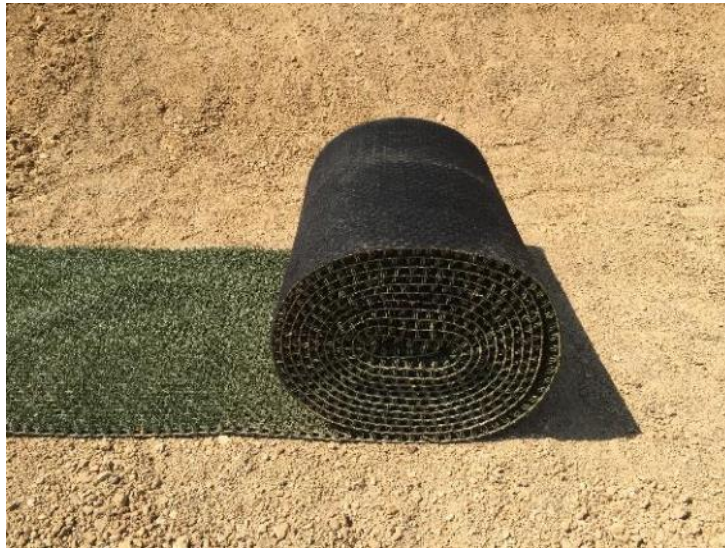
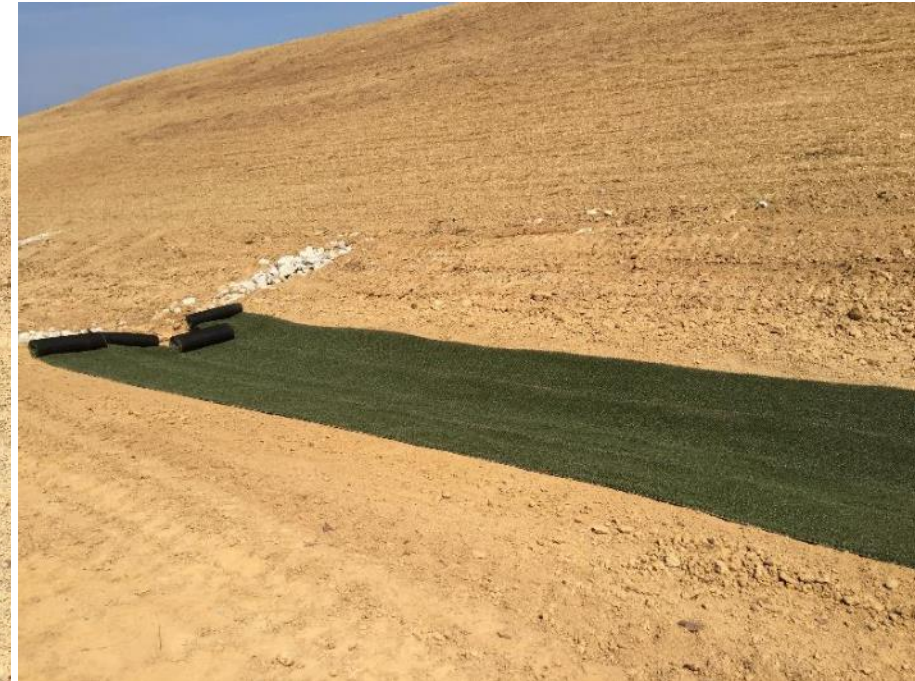
ShearForce10 Installed over cool season grass mix in high flow channel at the base of an overburden cap on September 10, 2019. Objective: Evaluate potential as rock riprap replacement in high flow areas.

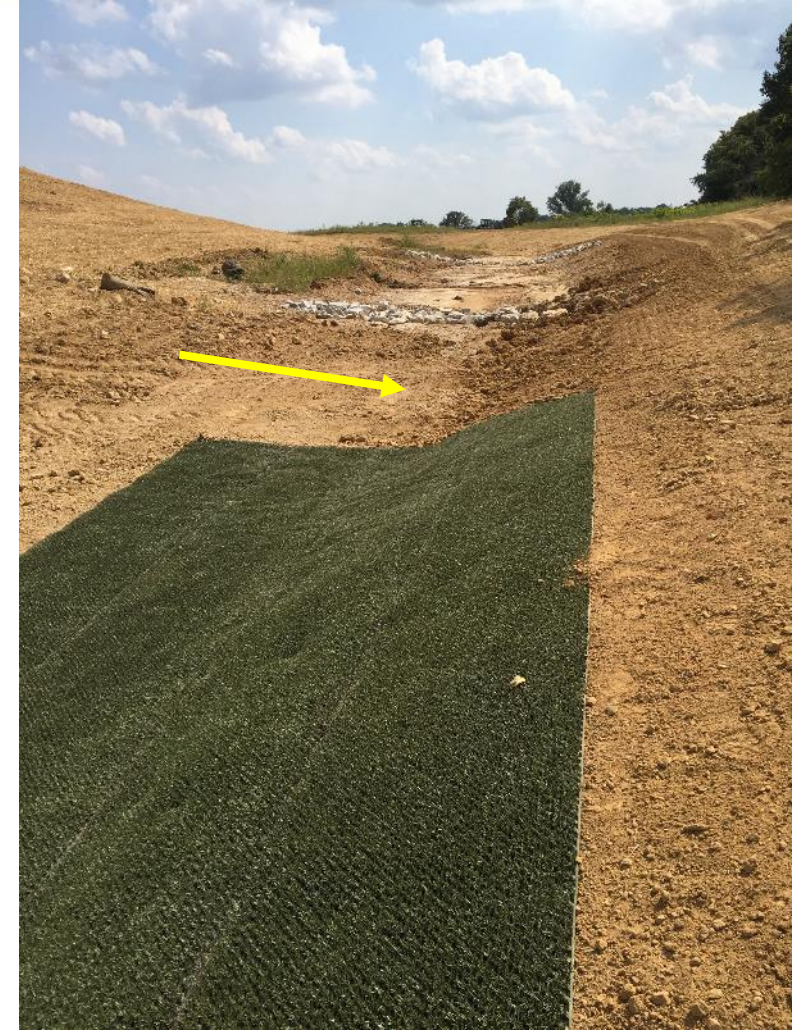
Mats were installed between rock checks using 8 inch sod staples and 6 inch fabric pins on 1.5 ft centers according to published InstaTurf installation guidelines. Note small sections of channel downstream and upstream of mats left unprotected for comparison.

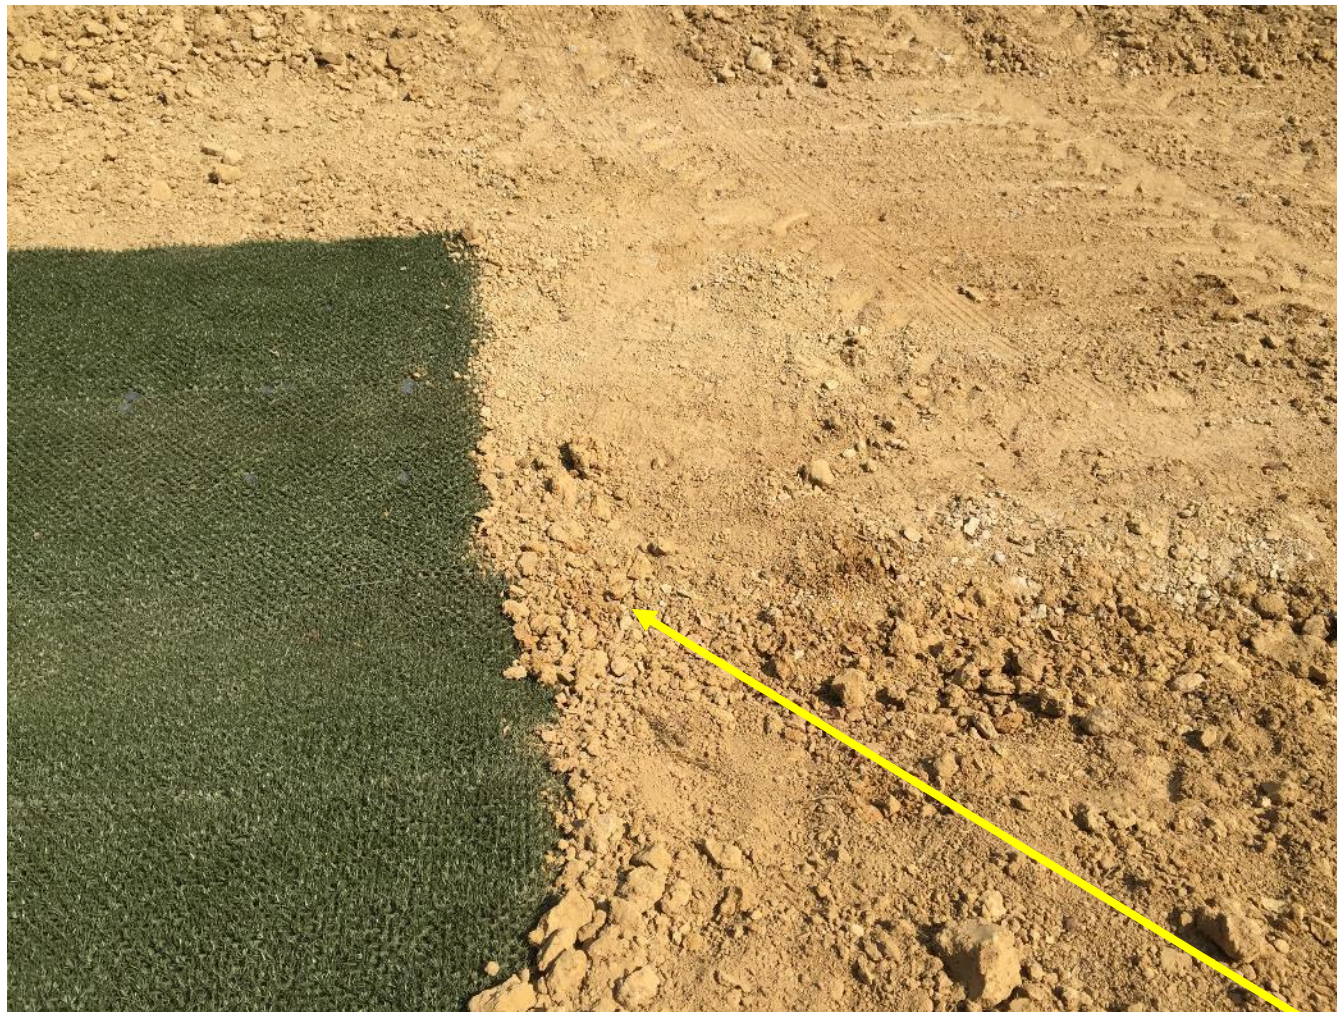
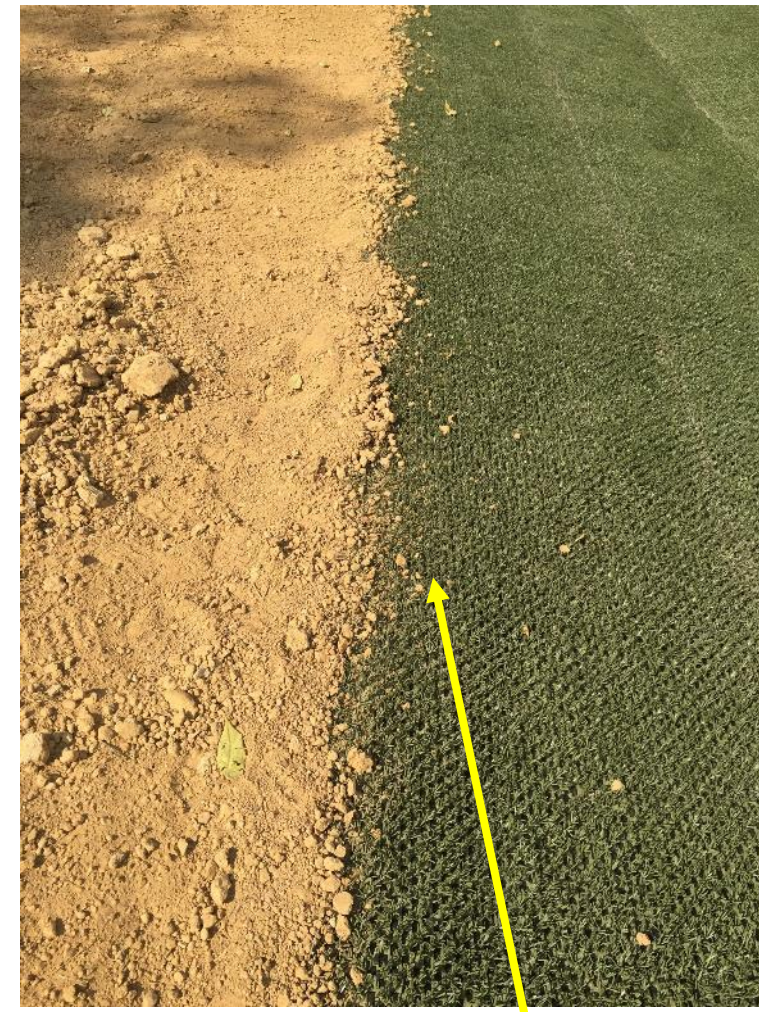
Upslope terminal ends of mats were trenched in approximately 6 inches (left). Mat edges at top of both sideslopes (Right photo) and downstream terminal ends were simply stapled on 9 inch centers with loose soil placed over edges.

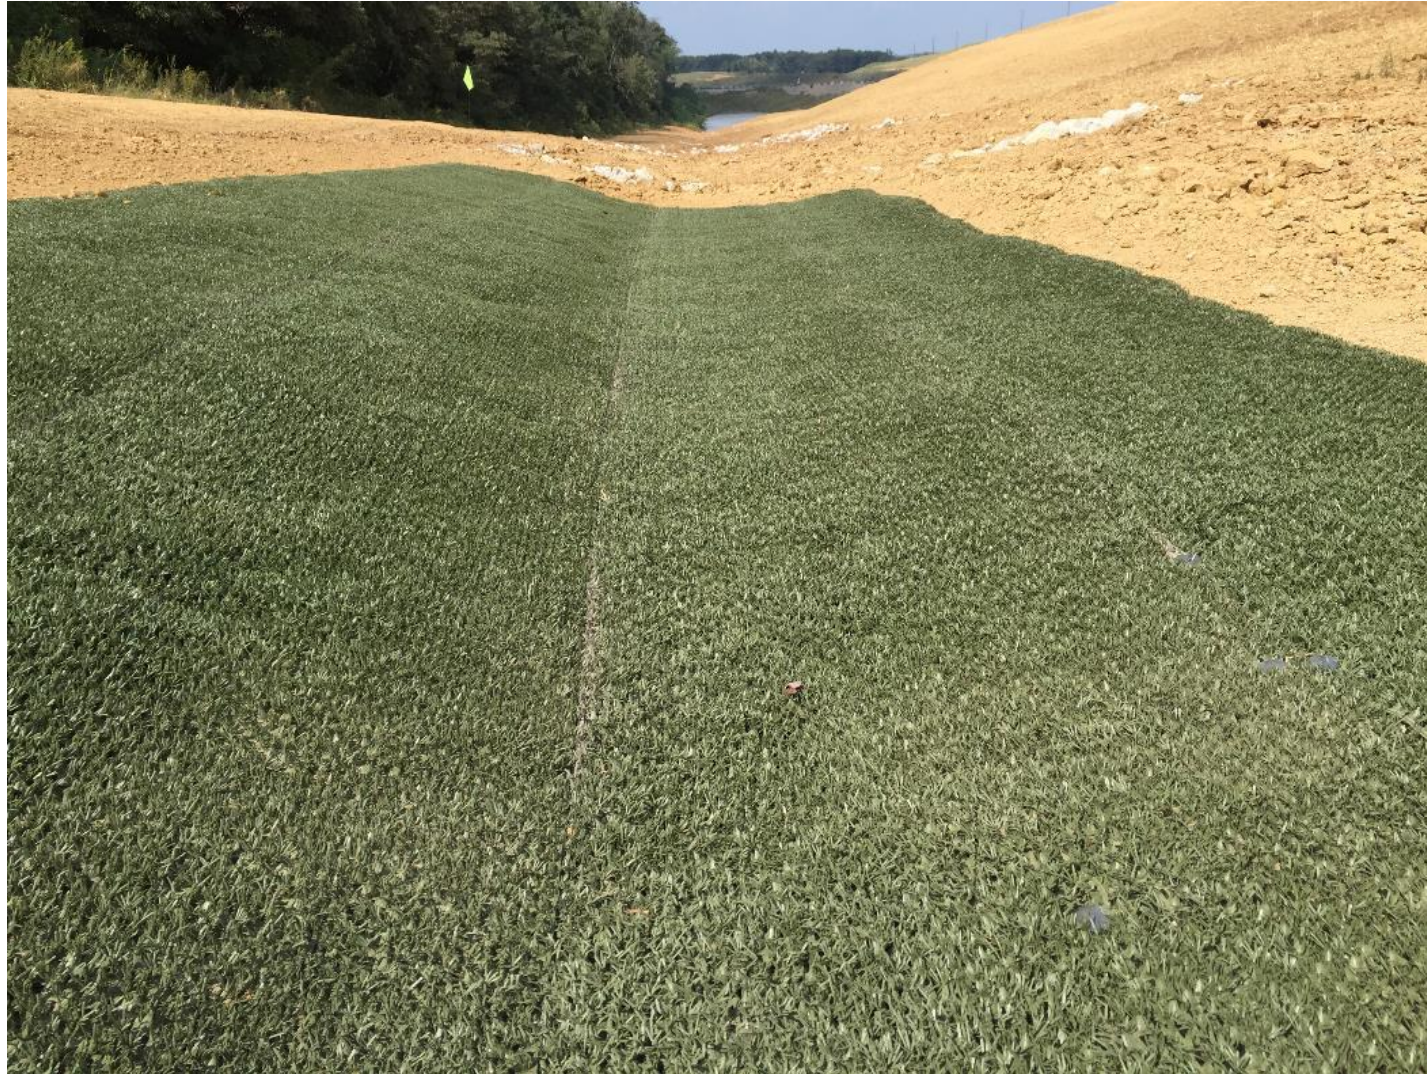
Completed ShearForce10 Installation looking down channel grade

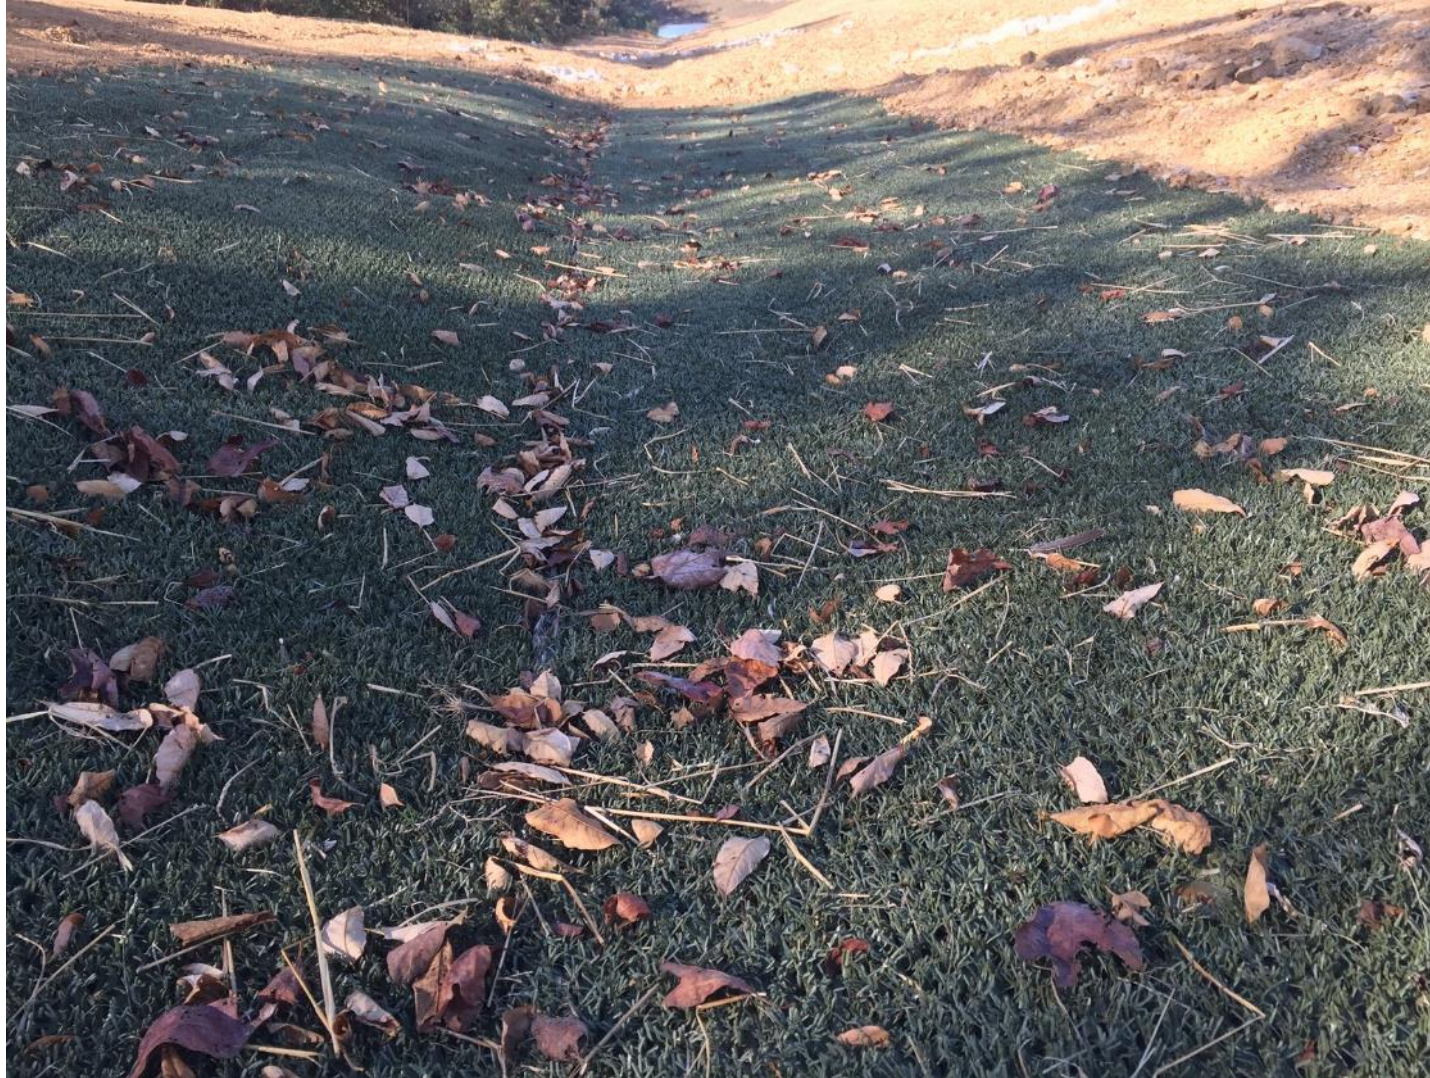
Due to the lack of rainfall in September (.6 inch total), very little germination had occurred by Oct 7

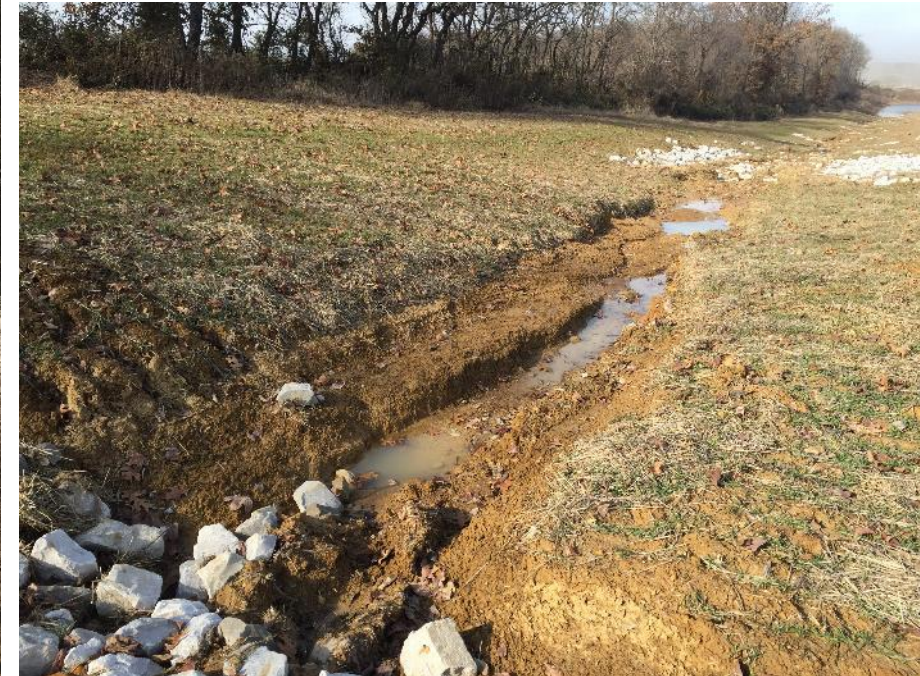
Major Erosion Damage of Unprotected Areas Caused by Late October Storm Flows

...Just two weeks later, the rains came, with major storm events on Oct 21 (1.65 in) and Oct 26 (2.2 in) wreaking havoc on straw mulched slopes/channel bottom and riprap check dams as apparent in these photos taken Nov 20. Over 6.5 inches of rain fell in October, what a mess!

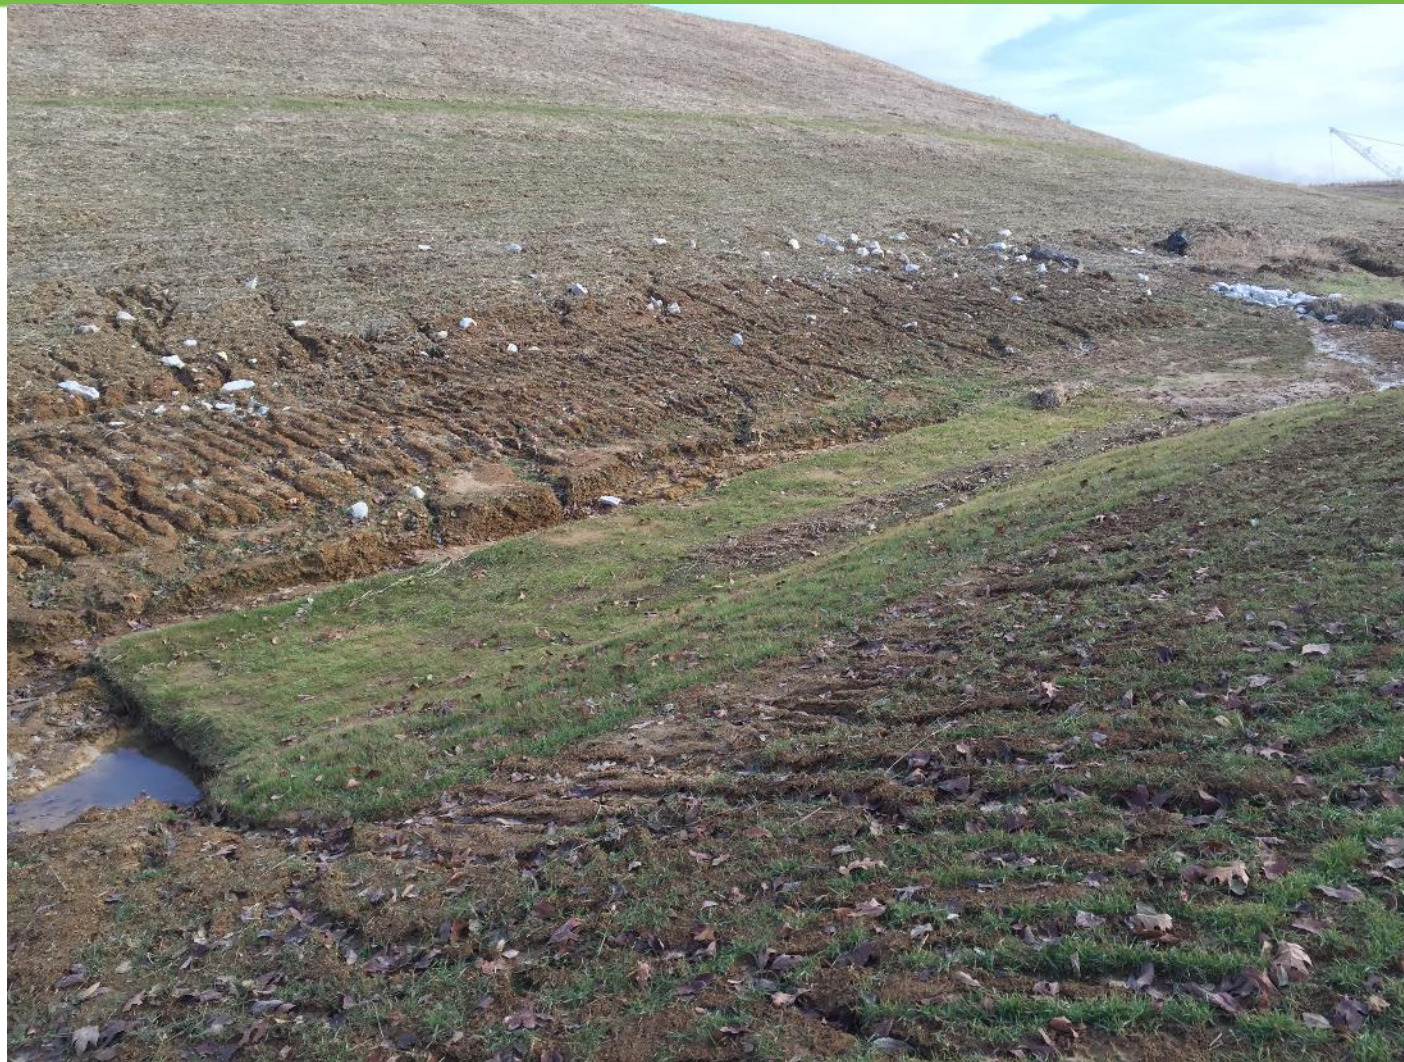
Nov 2019 - ShearForce10 Channel Test Section

As illustrated by the severe erosion and scour of adjacent unprotected soils , the ShearForce10 performed incredibly well at armoring the channel, while growing and reinforcing natural grass under extreme conditions!

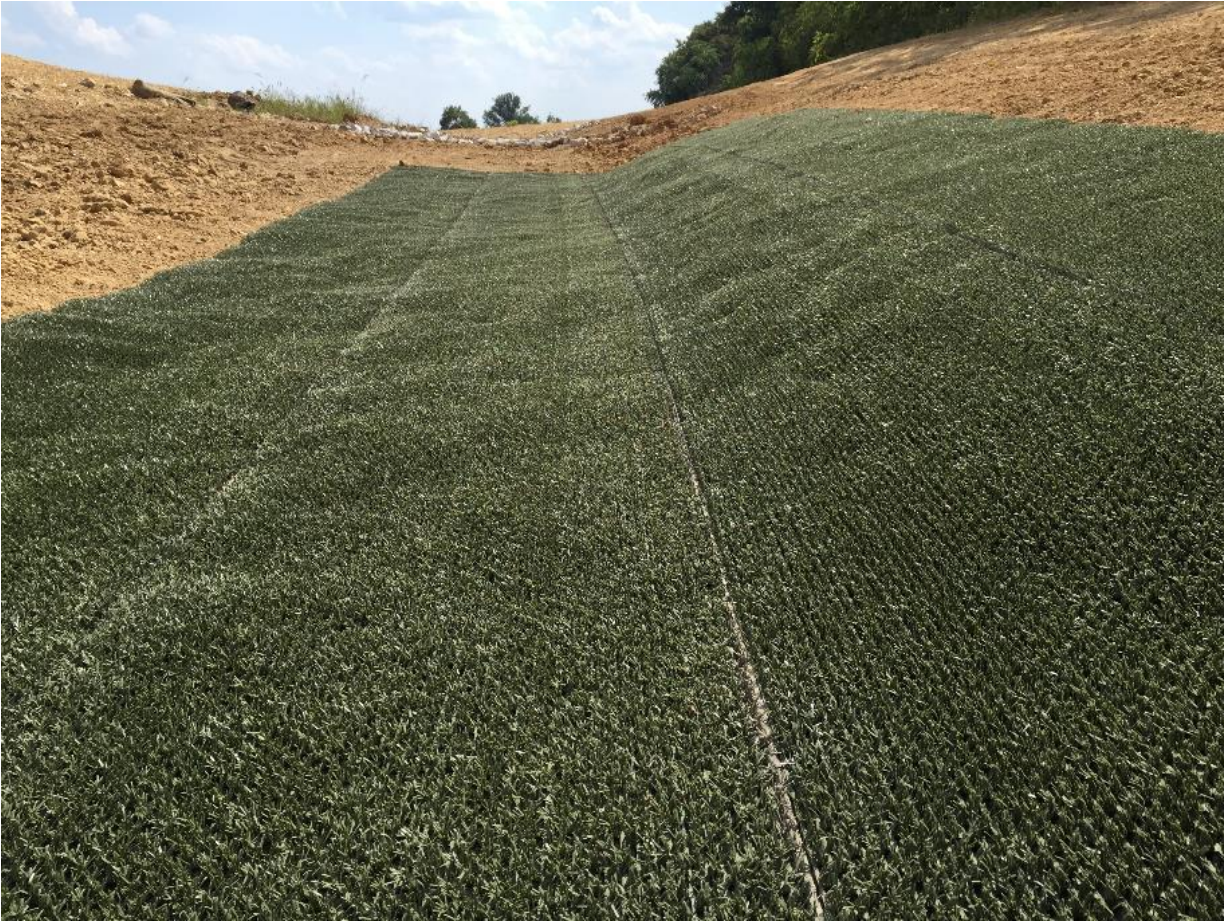
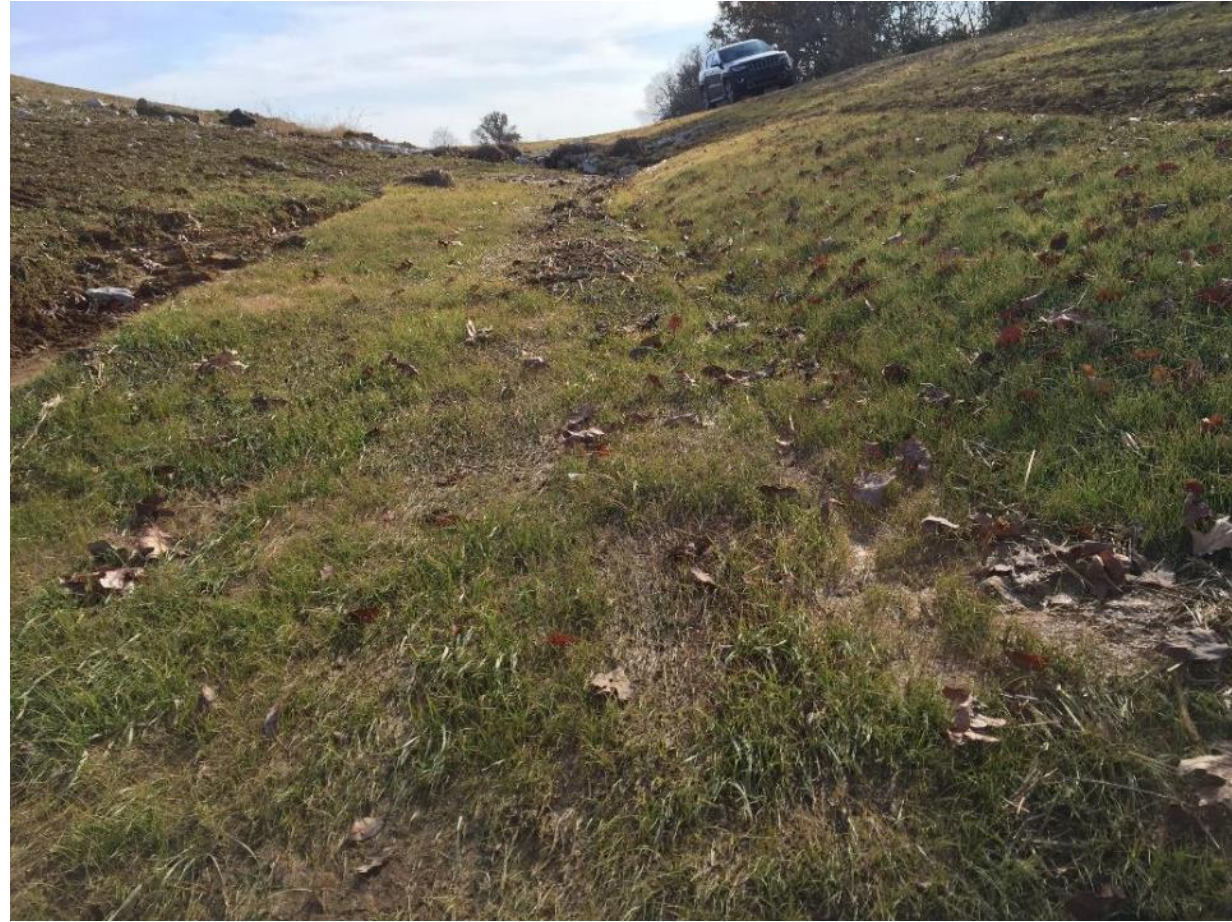
Upslope view of ShearForce10 just after installation on Sep 10 (left) and on Nov 20 (right).

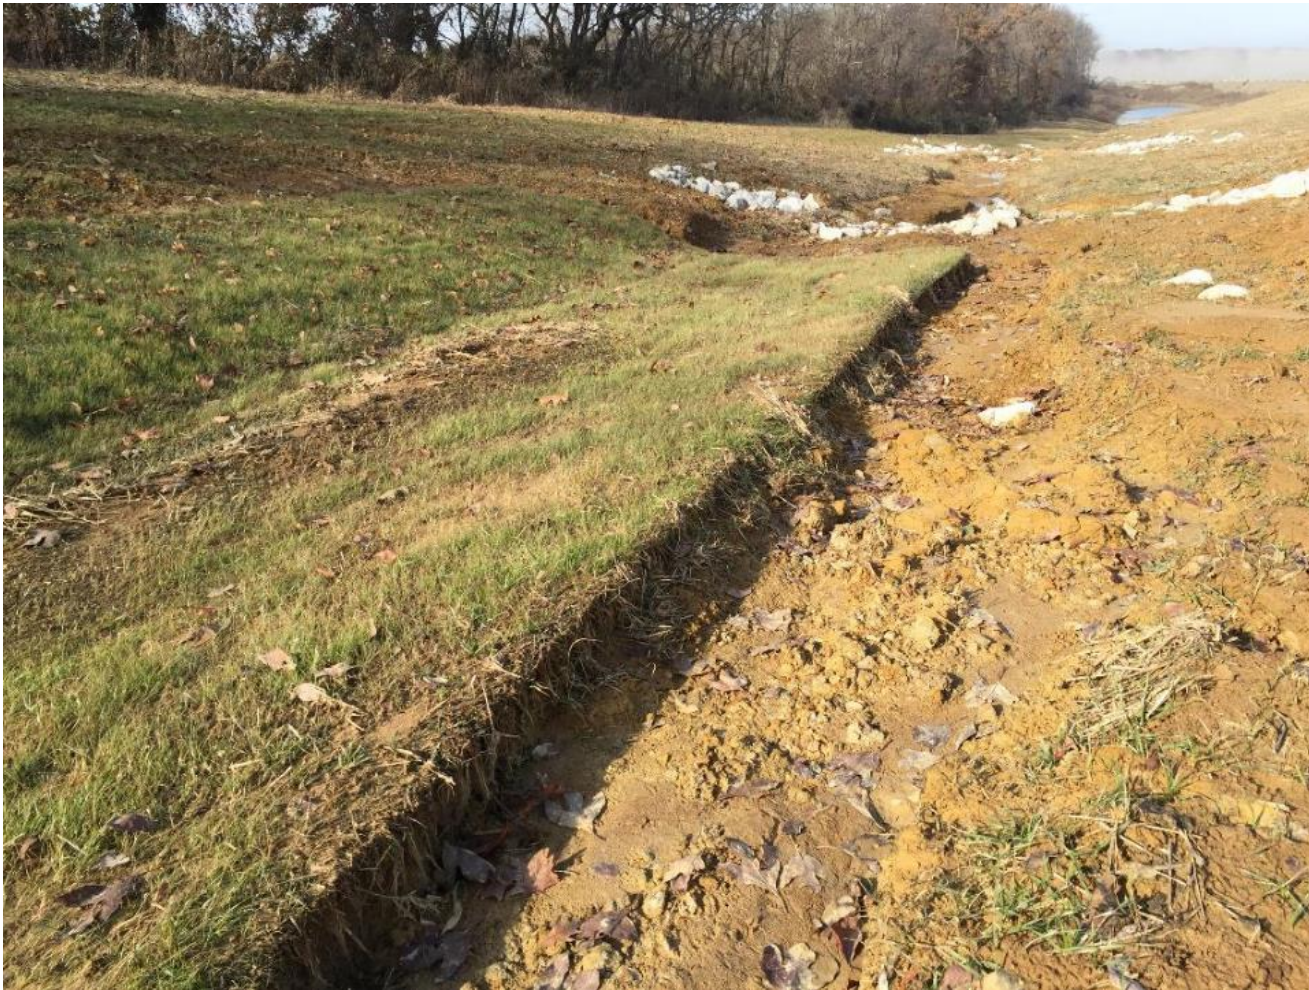
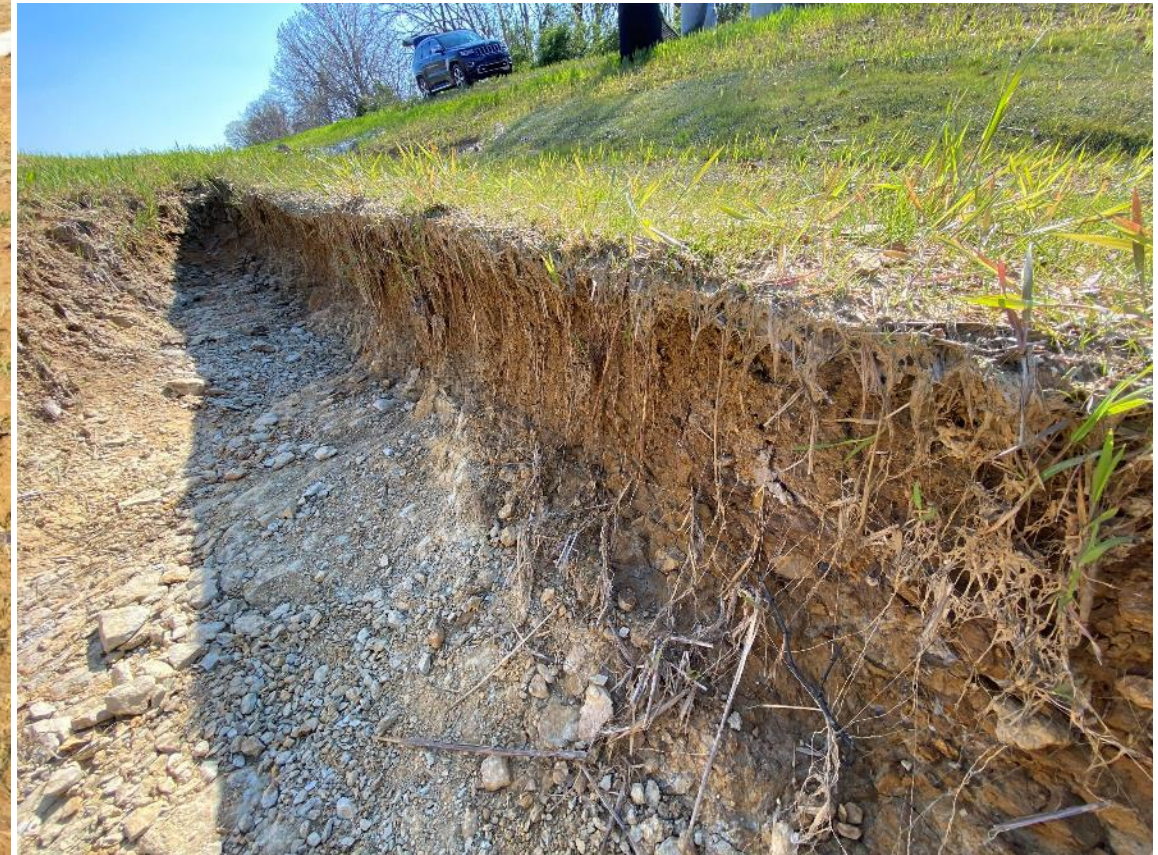
The Consequences of Underestimating Flow Depth

But wait, there's more. Apparently we should've used more ShearForce10! The right sideslope (looking downstream) where no ShearForce10 was used was badly scoured by over 8 inches. Incredibly, the ShearForce10 prevented erosion of soils and vegetation directly under it. Never seen anything like this before!

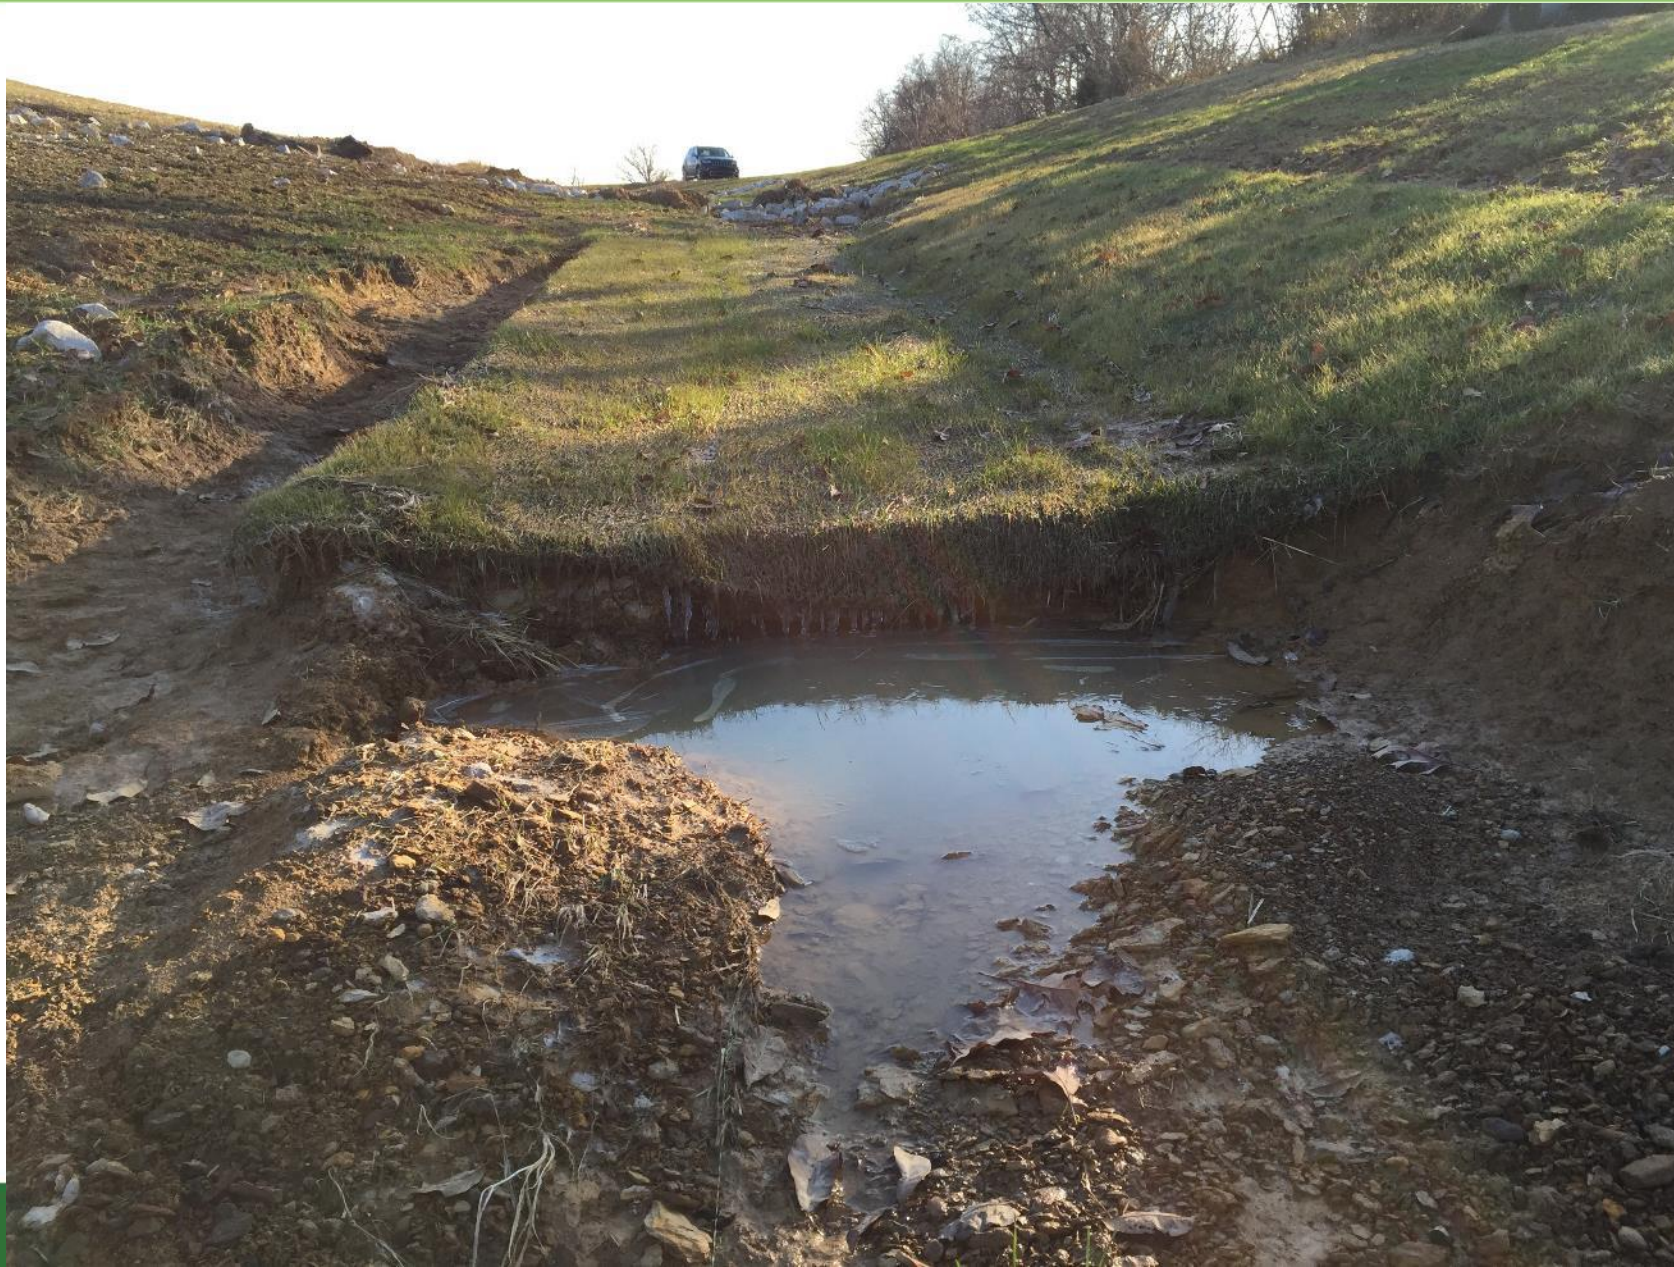
Dec 2019 - Scour of Unprotected Downstream “Control” Section

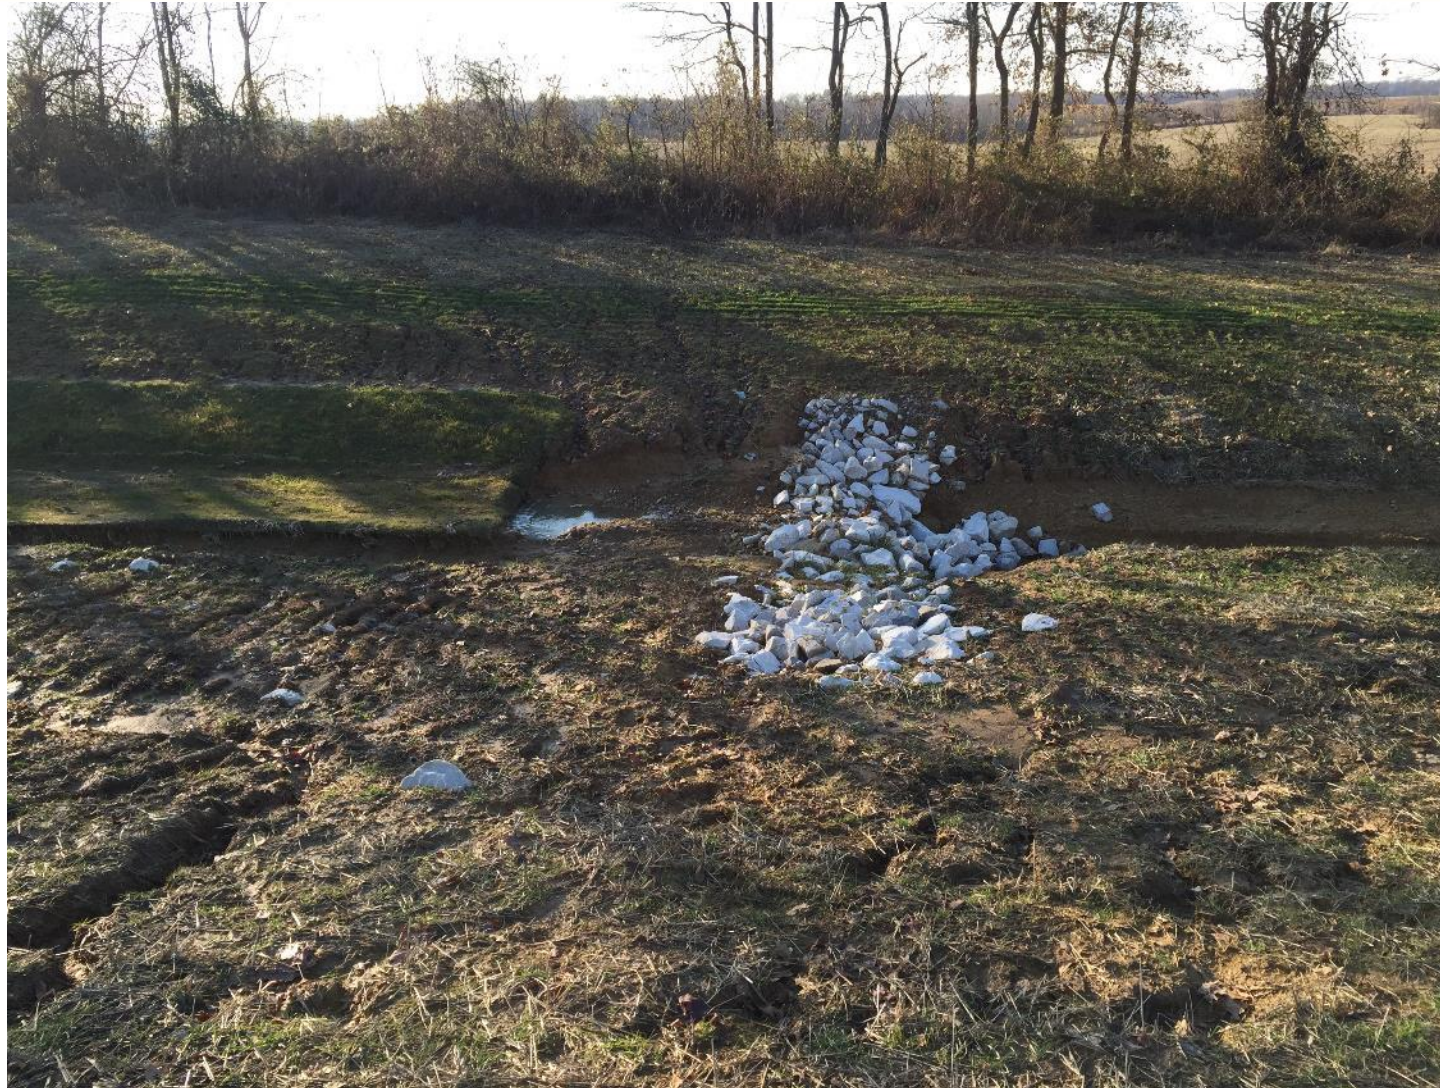
Scour of Unprotected Downstream “Control” Section

The unprotected area downstream from the ShearForce10 and rock check exhibited severe scour.

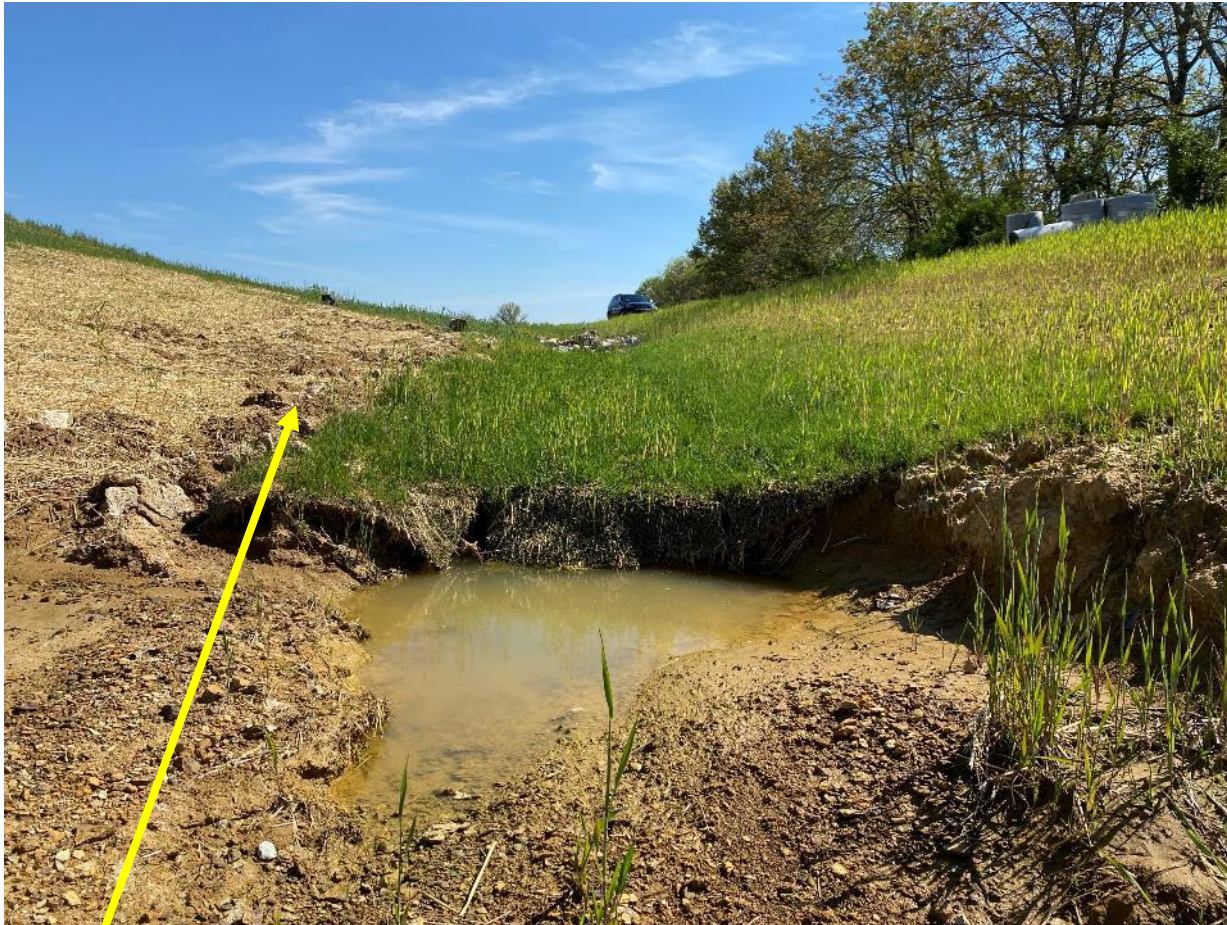
May 1, note in-filled gully left side of test section

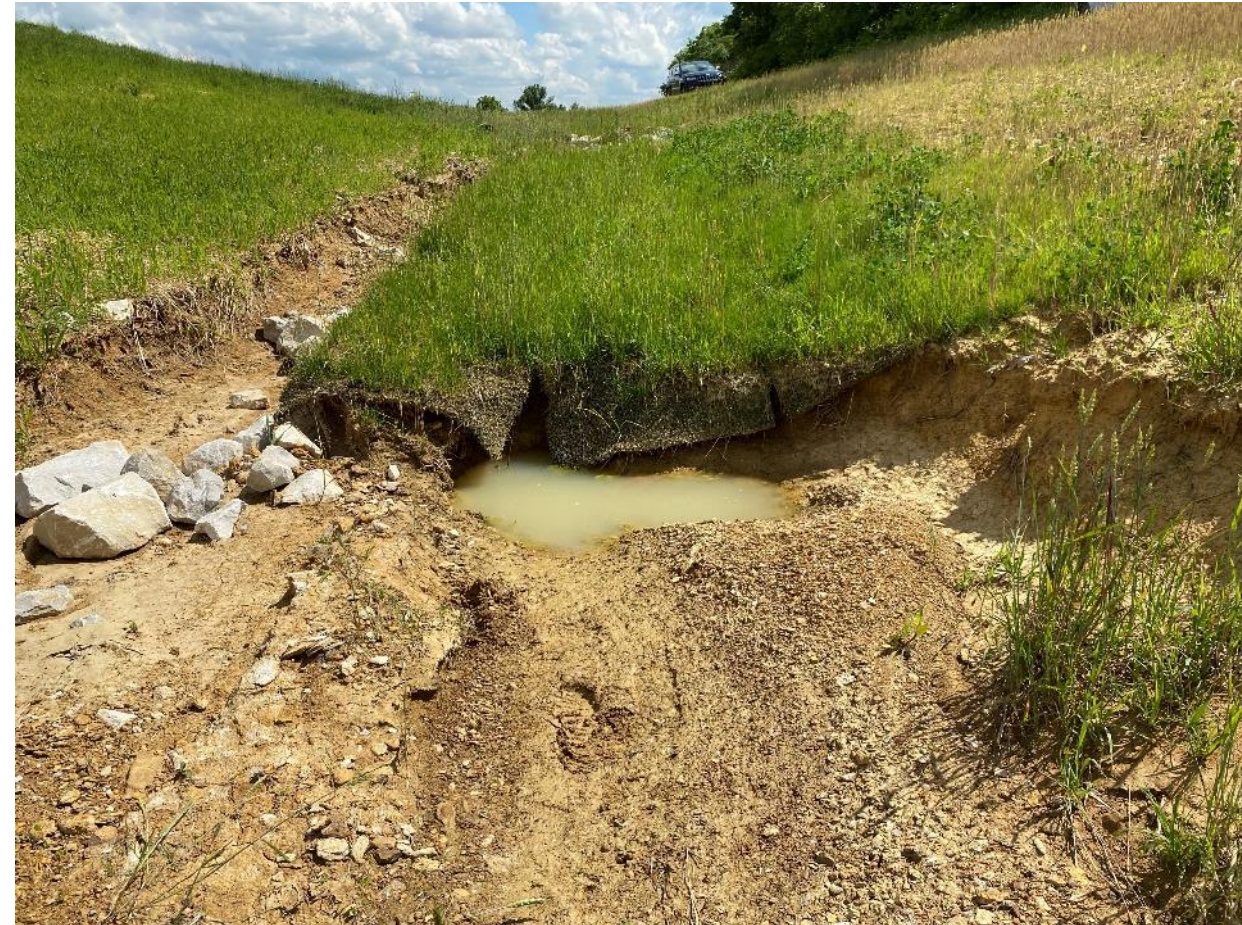
May 28, in-filled soil washed out, rock deposited from check dam upstream

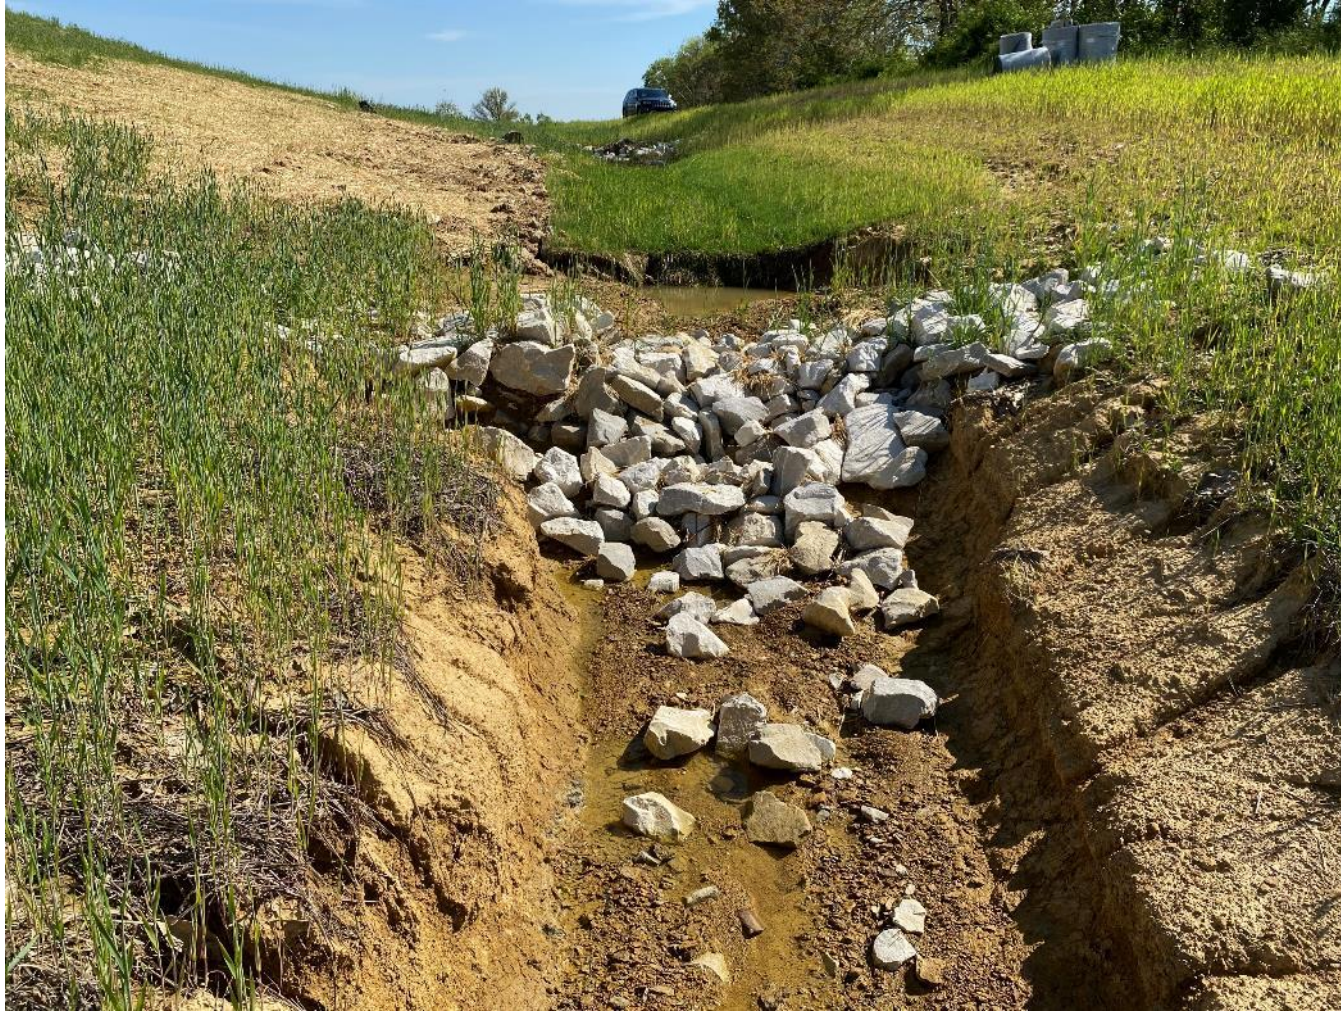
May 1, downstream rock check dam damage

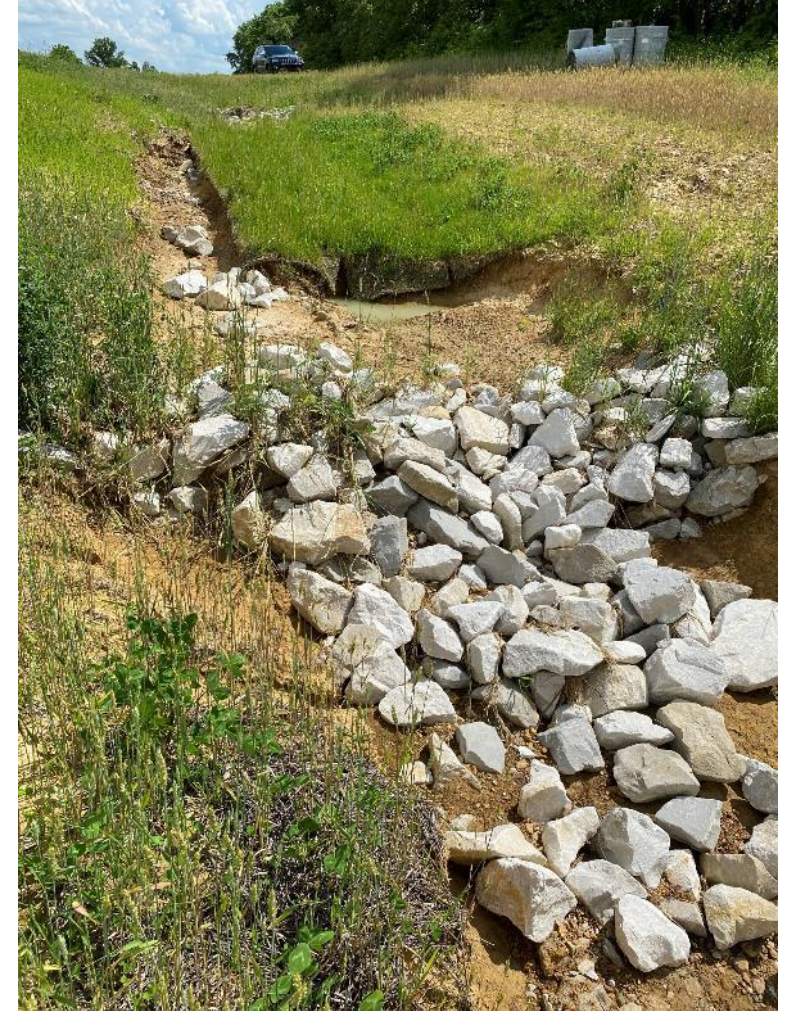
May 28, leveled rock check dam
