- **Project Name:** Peabody Coal Constructed Streambanks Stabilization
- **Product:** InstaTurf™ ShearForce10™ ECTRM
- **Application:** Overwinter Protection and Vegetation Establishment on Constructed Streambanks

- **Project Owner:** Peabody Coal, Somerville IN Mine
- **Regulatory Oversight:** Army Corps of Engineers
- **Time Frame:** Installation of ShearForce10 on Oct 25, 2018

Peabody Coal Streambank Stabilization Project

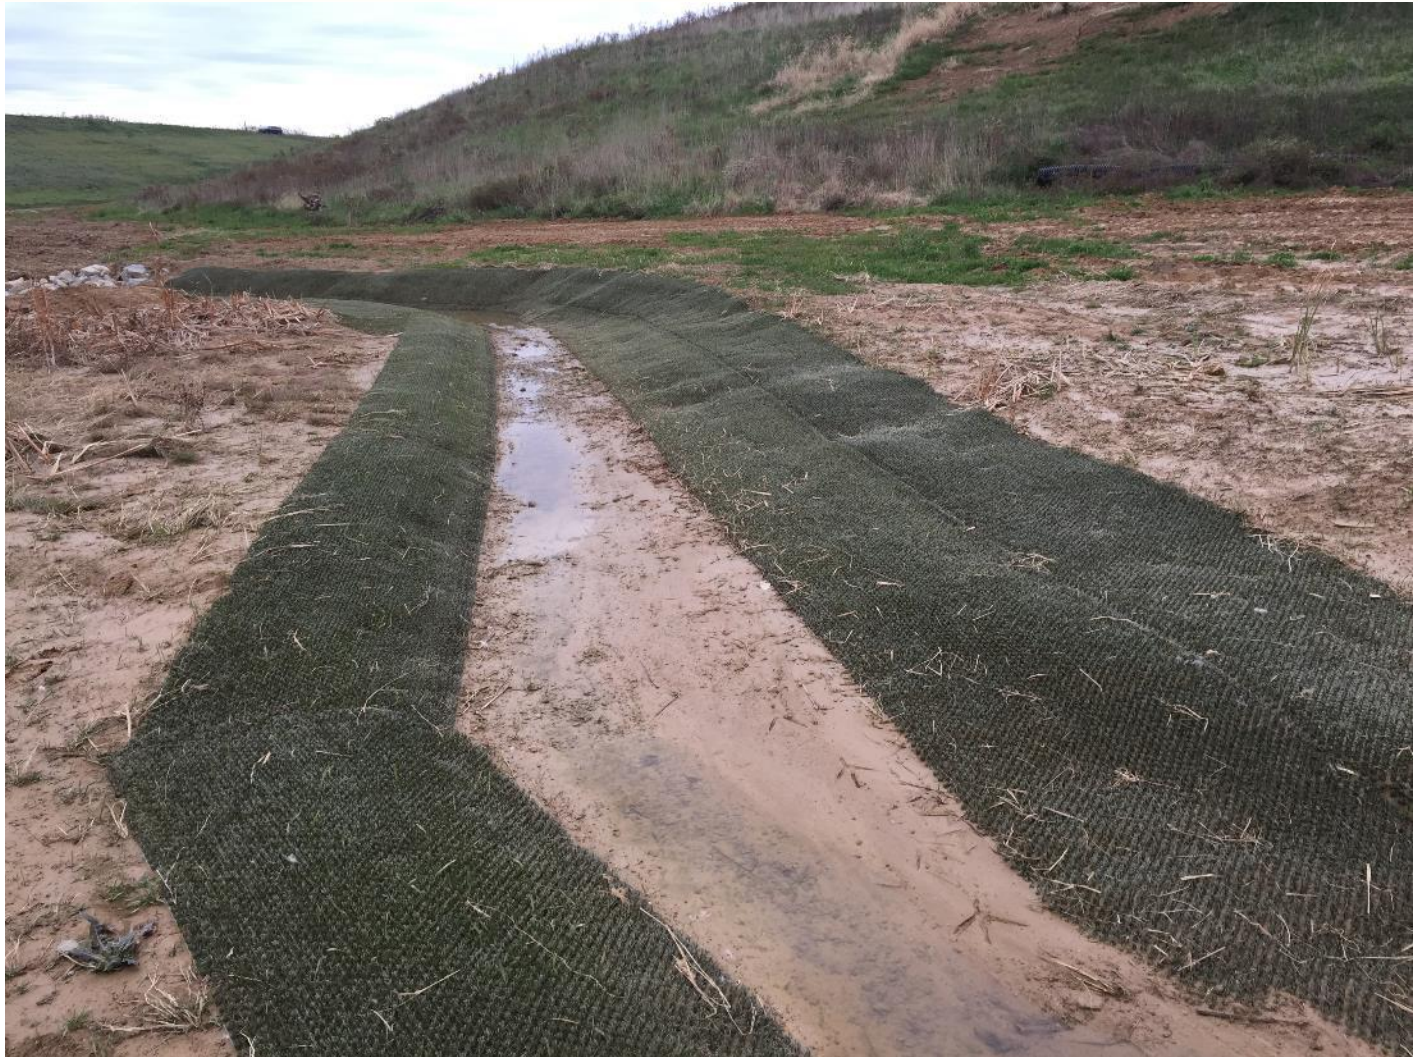
InstaTurf ShearForce10 ECTRM Installed October 25 on seeded streambank

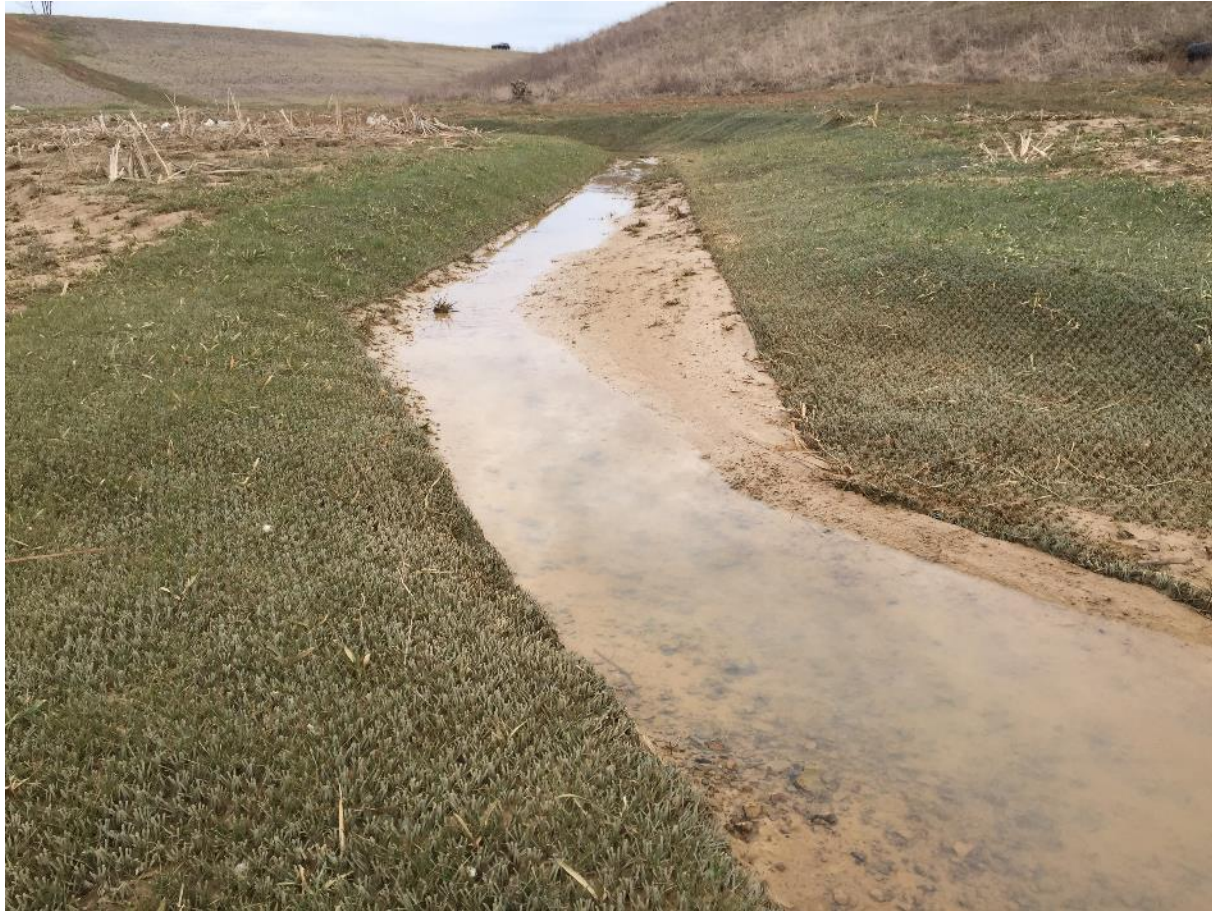
The ShearForce10 did an excellent job of protecting the streambanks through a two inch rainfall on Nov 1, which generated bank-overtopping flows. Note the grasses starting to emerge thru mats in winter.

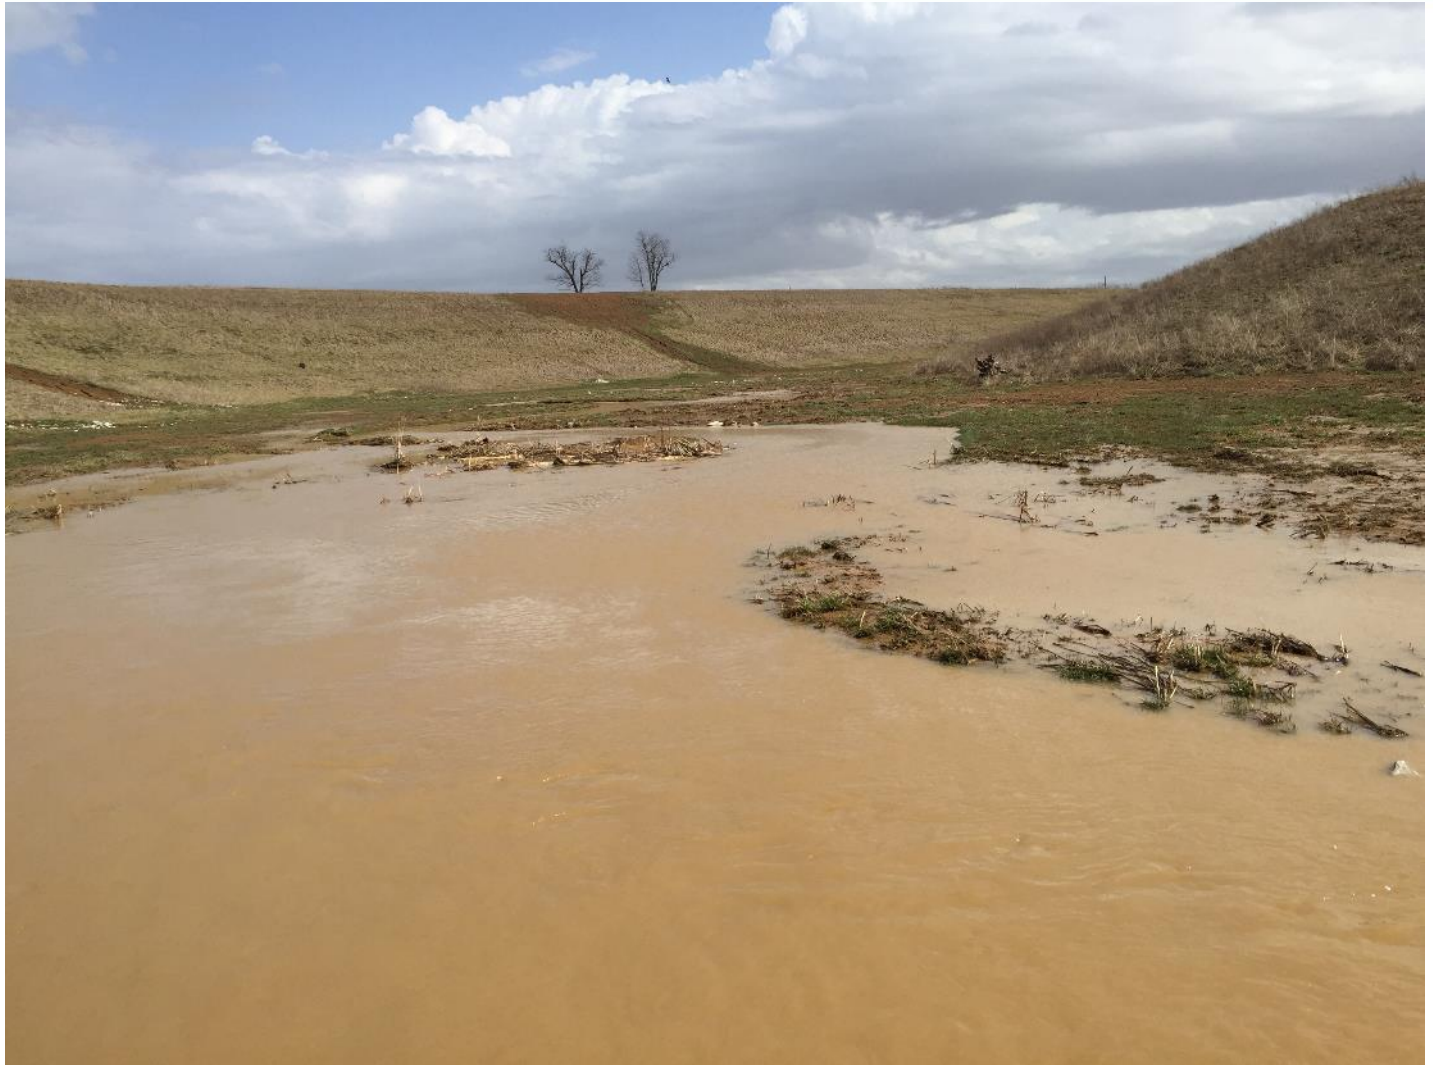
Unusually heavy rains throughout the fall, winter and spring months flooded the stream channel on numerous occasions

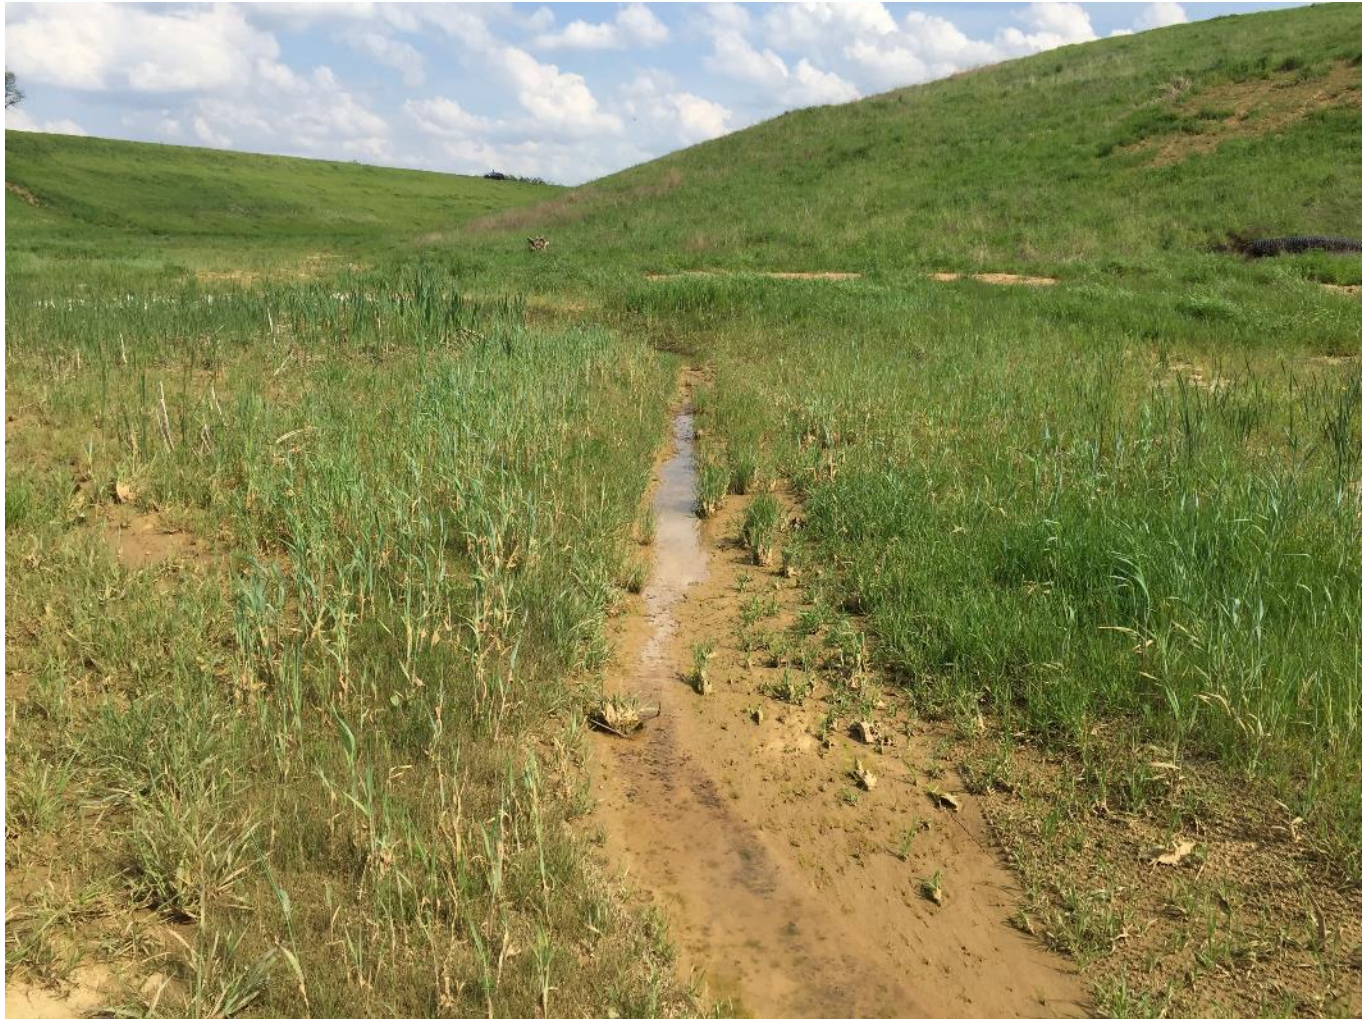
ShearForce10 effectively armored the streambanks through all flood events, sustaining a good stand of vegetation by April 30

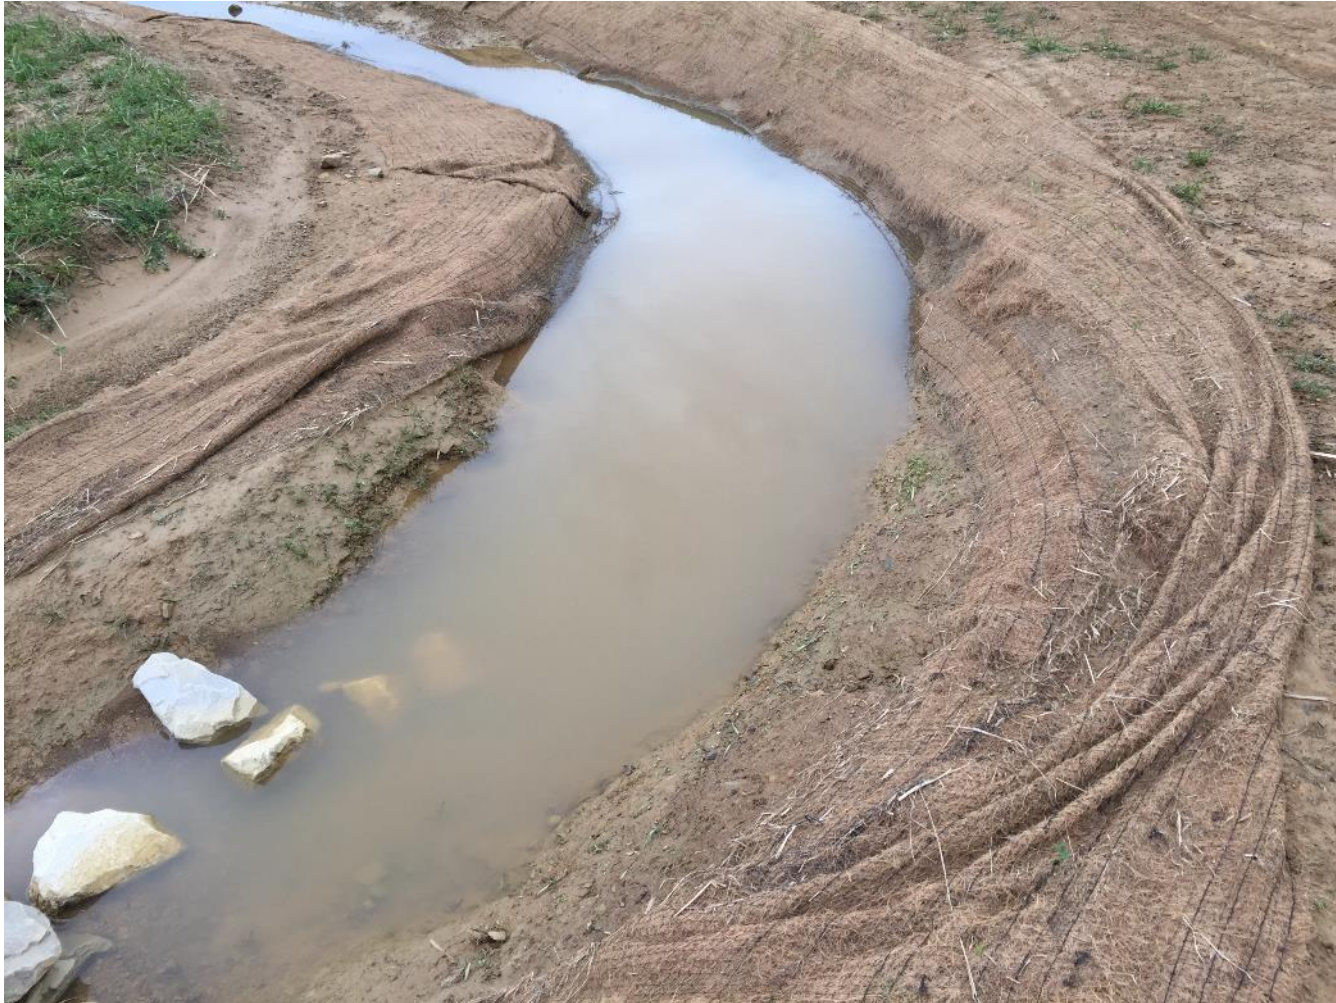
The two inch rainfall that occurred one week after installation severely damaged coconut erosion control blankets installed on other sections of the stream channel and initiated significant bank erosion

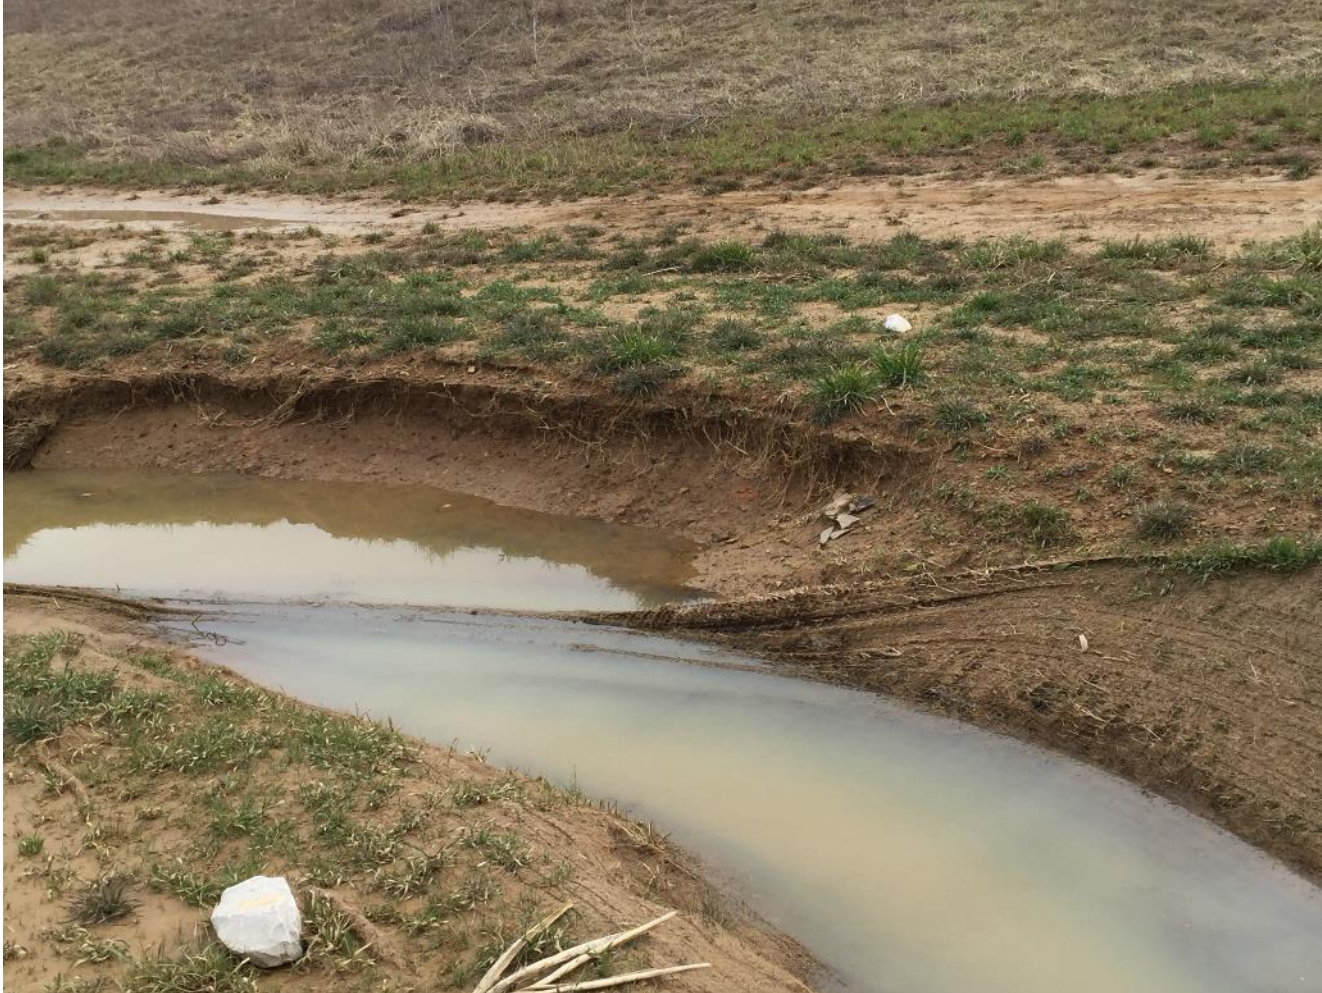
Many banks along the stream channel where coconut blankets had been installed were on the verge of collapsing by early spring due to severe undercutting

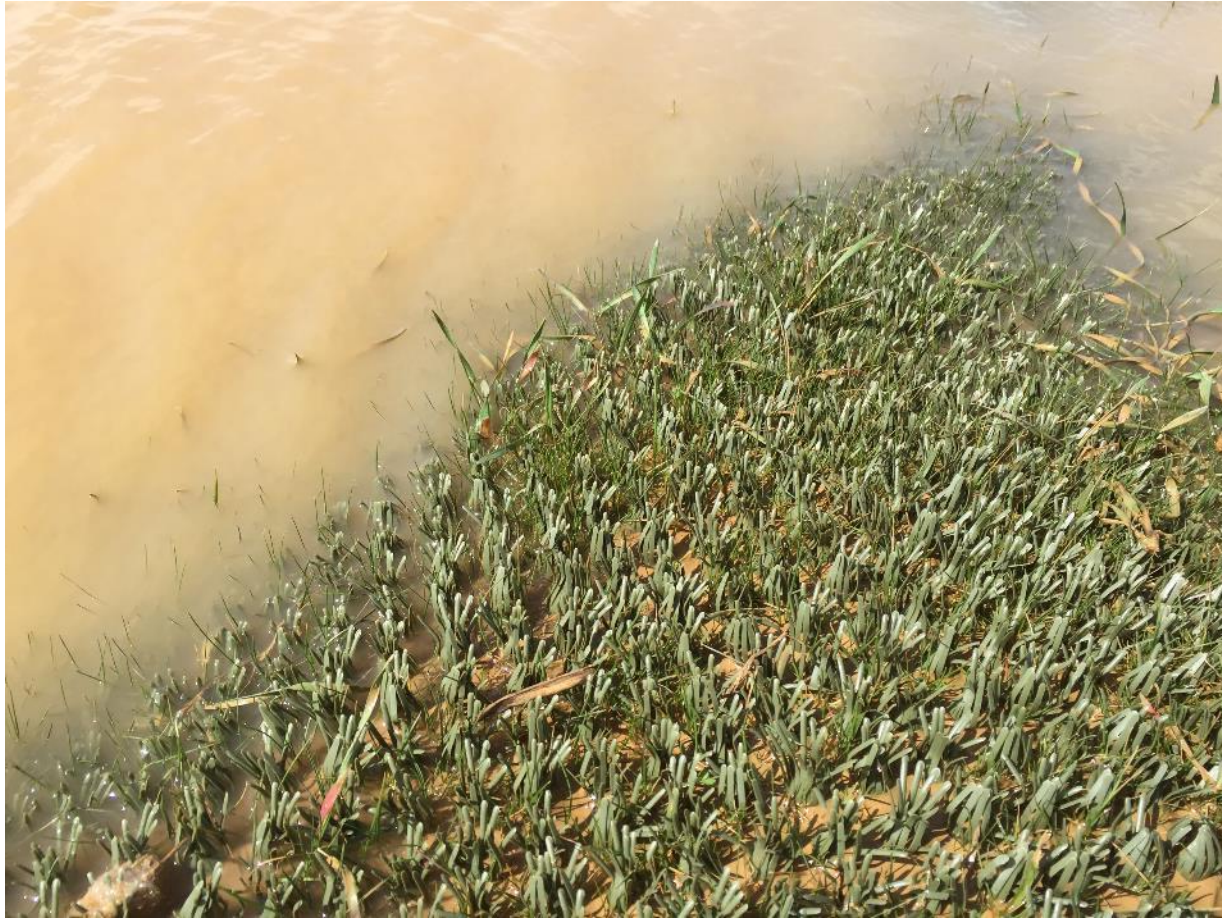
The ShearForce10's simulated turf structure captured sediment in stream flow which further enhanced the mats' erosion control capabilities by locking down material between anchor points

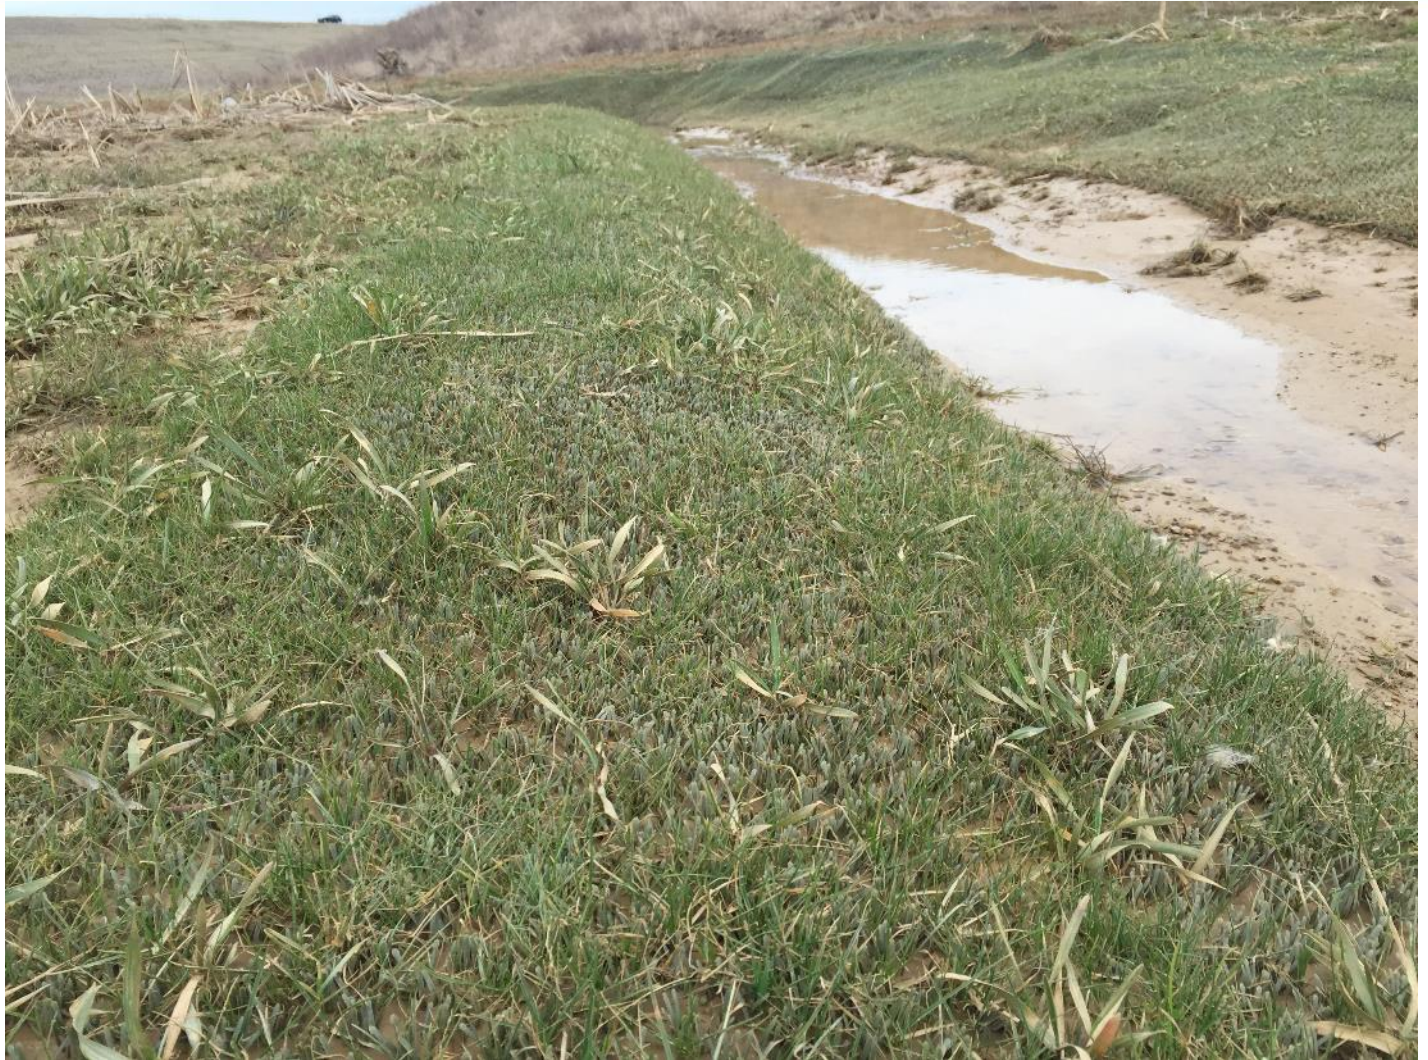
Vegetation growth in mid-March

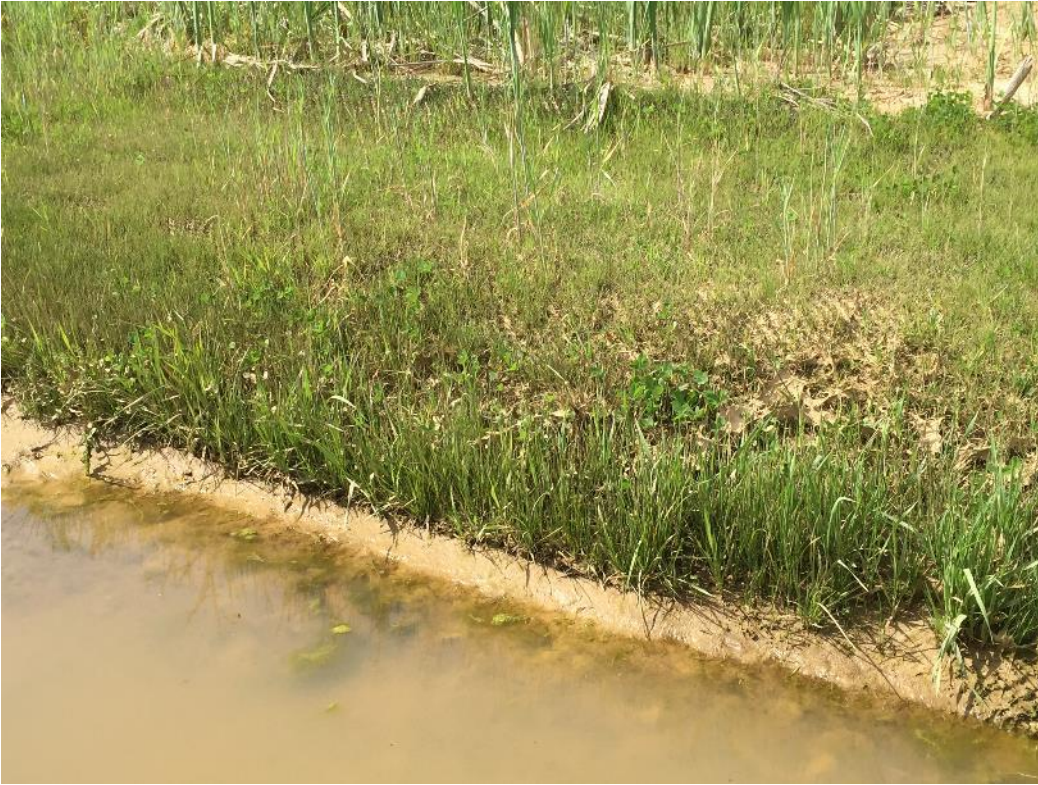
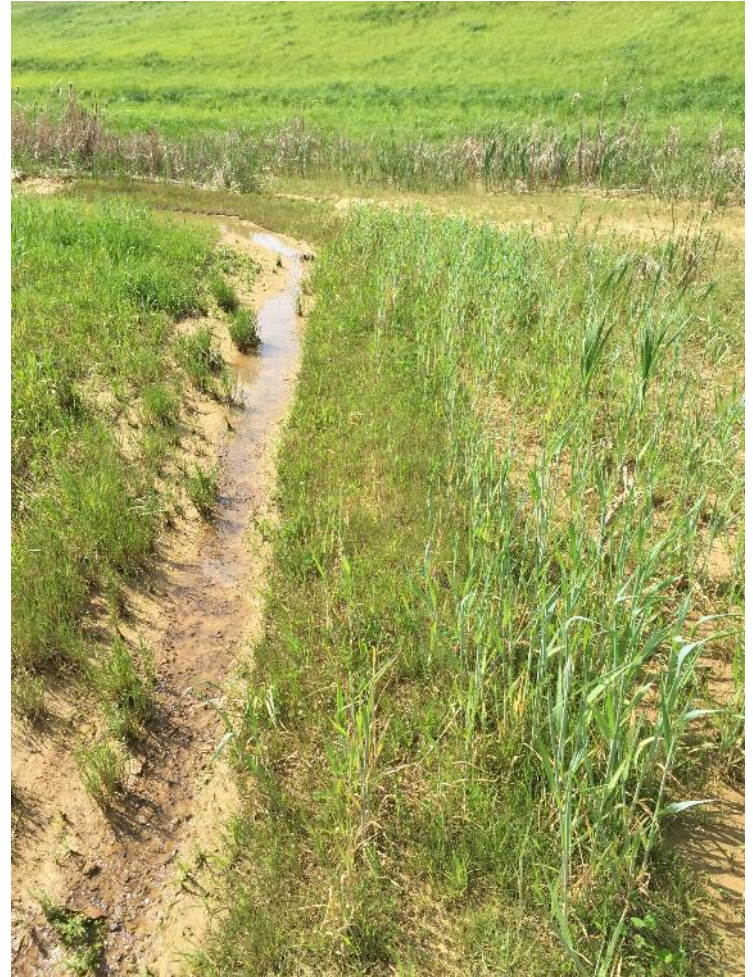
April 30, note the distinct lines formed by the edges of the ShearForce10 mats along the shoreline...

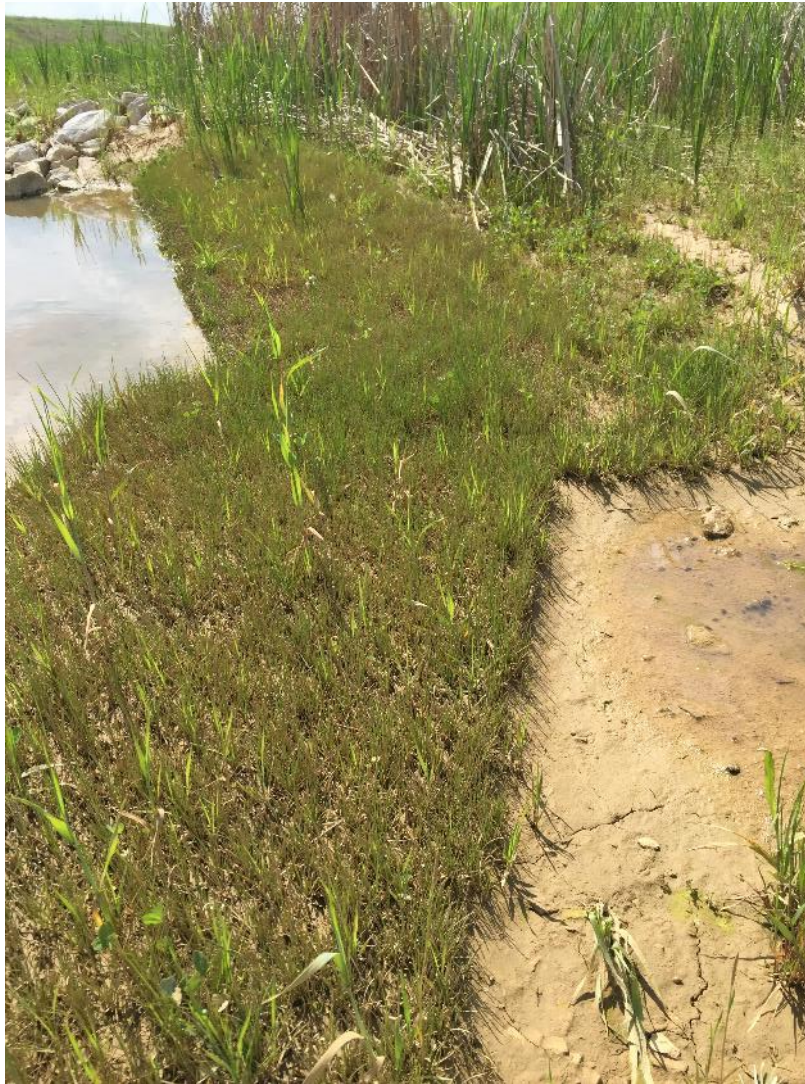
...Where ShearForce10 ends, so does the vegetation.

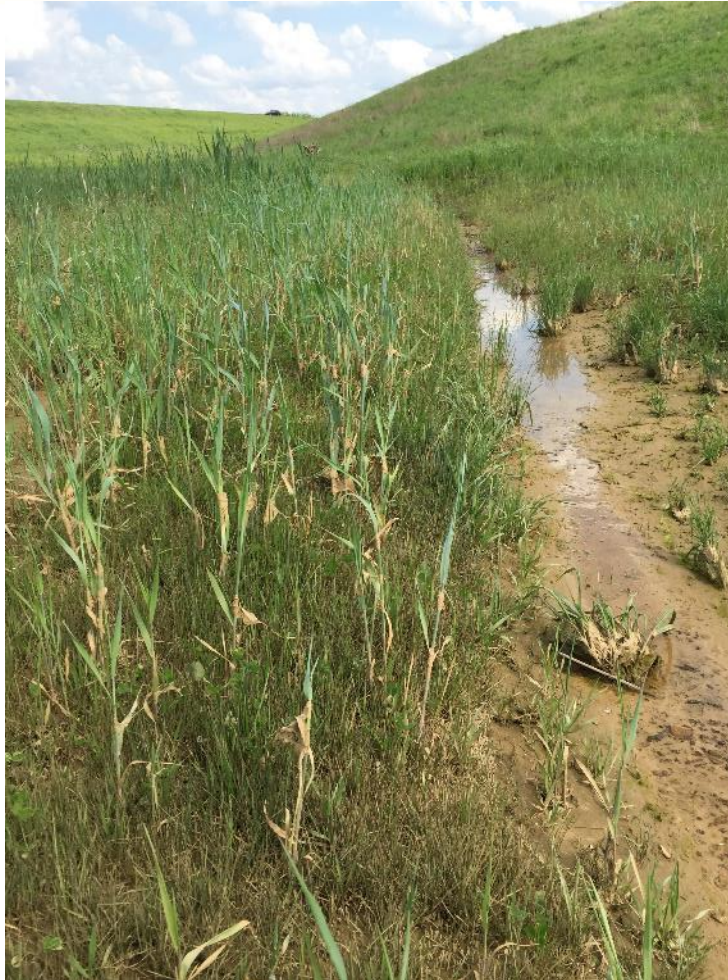
InstaTurf ShearForce10 successfully stabilized the banks of the stream through the fall, winter and spring months, with vegetation now permanently reinforced against future flood events.
