PROJECT CASE STUDY

PROJECT OVERVIEW

The Eastern Coast of Virginia

Protecting a power substation experiencing heavy precipitation and repeated TRM/sod failure.

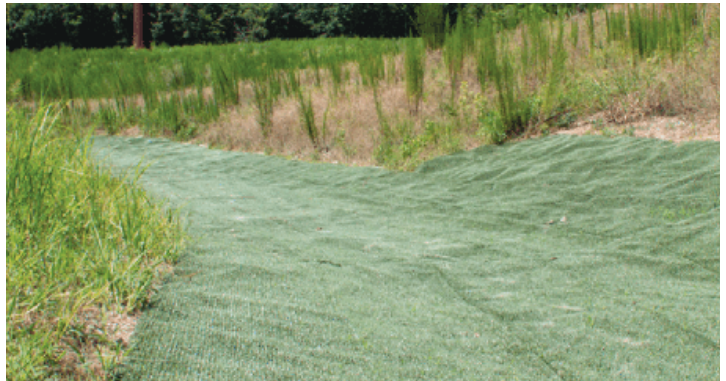
ShearForce10 channel installation

Del Fuller of Ferguson Waterworks recommended InstaTurf ShearForce10, a lightweight and effective erosion solution. The product was chosen over rock, and its inherent logistical challenges. Installation was quick and cost-effective, making it an ideal choice.

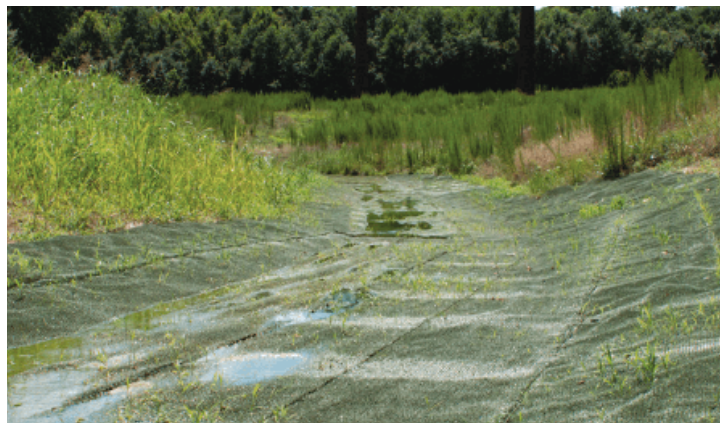
ShearForce10 post-hurricane

Shortly after installation, Hurricane Isaias struck, subjecting the ShearForce10 to heavy rainfall and strong winds. Del inspected the site post-storm and was pleasantly surprised to find no visible soil loss. ShearForce10 had withstood the challenge, with grass already growing through it.

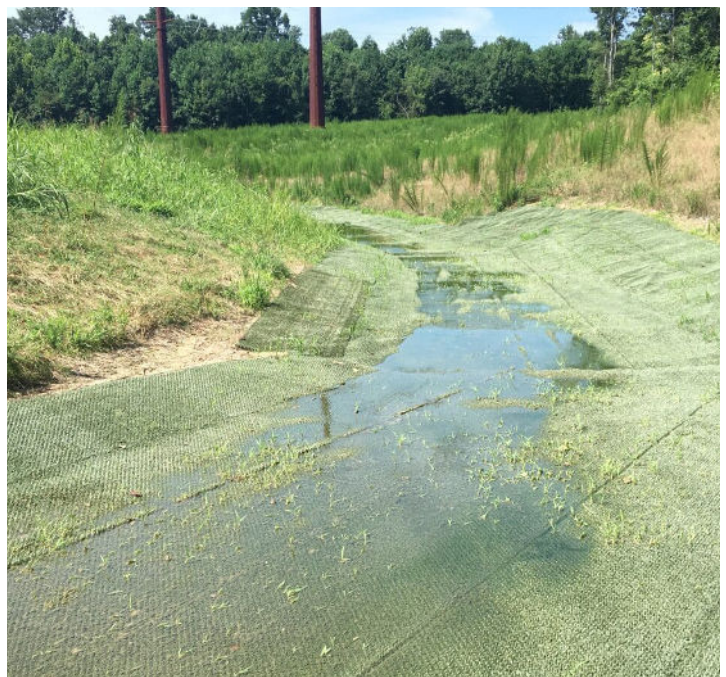
ShearForce10 post-hurricane
